POVODÍ VLTAVY

DROUGHT AND WATER QUALITY IN RESERVOIRS

JINDŘICH DURAS, MICHAL MARCEL

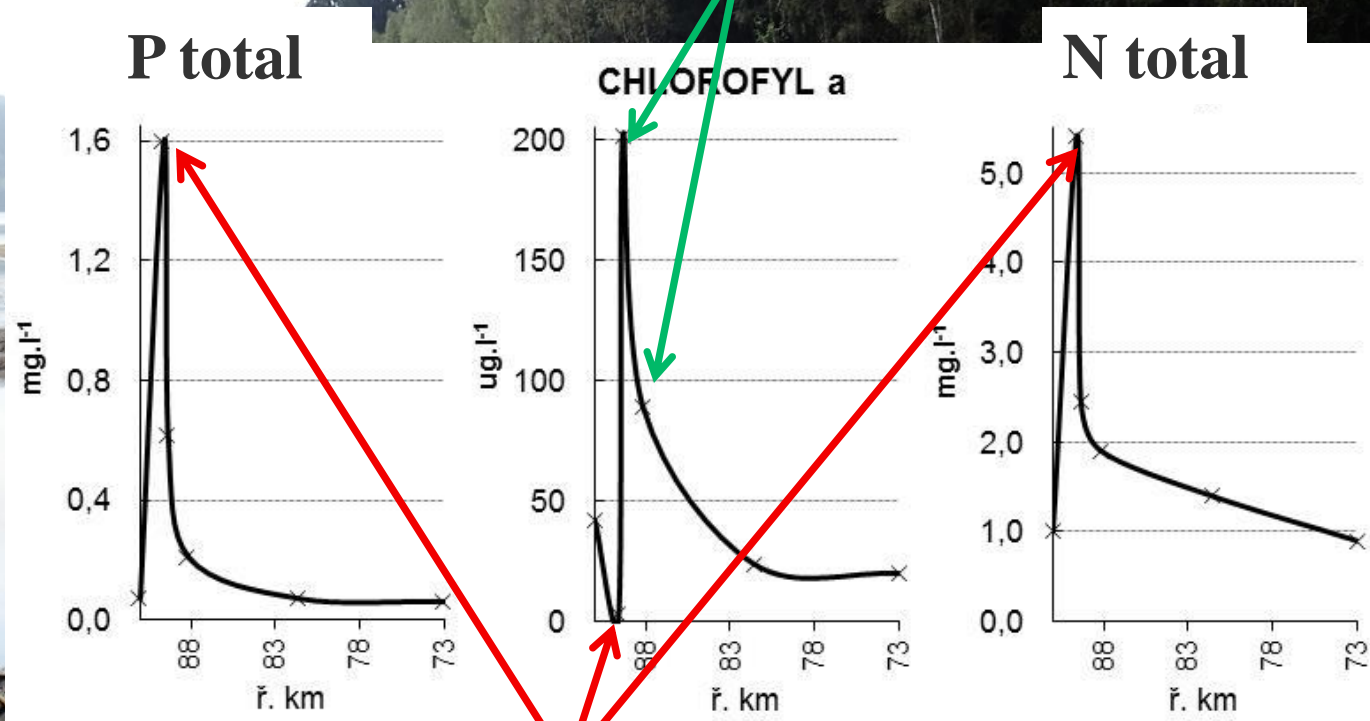
Longitudinal profile of a small stream Štřela:
an inflow of Žlutice drinking water reservoir

2 fishponds

WWTP input

fast degradation of pollution, nutrient retention

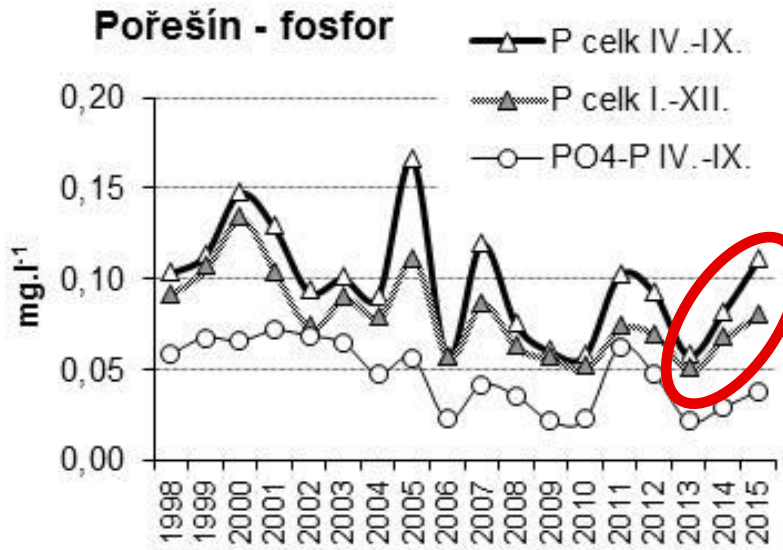
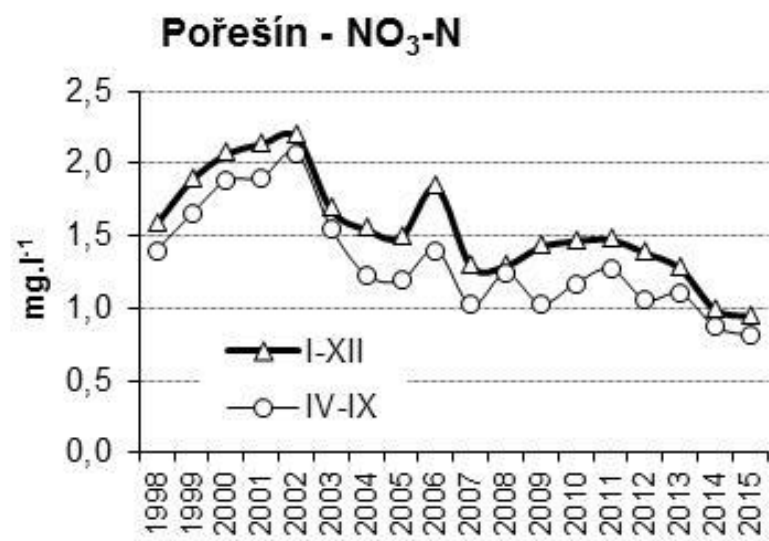
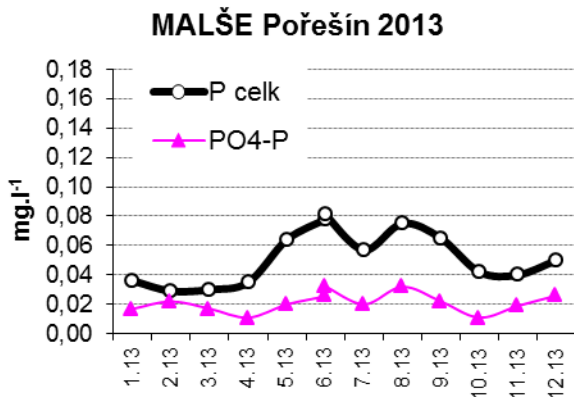
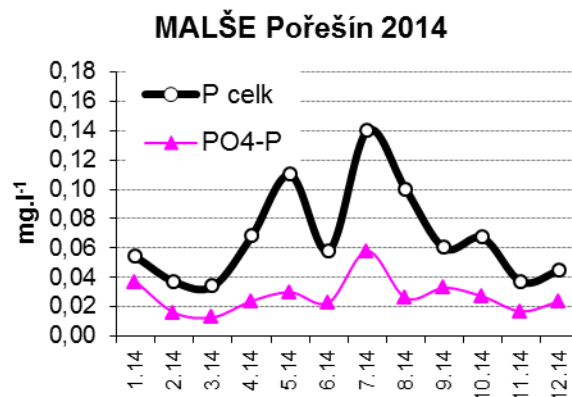
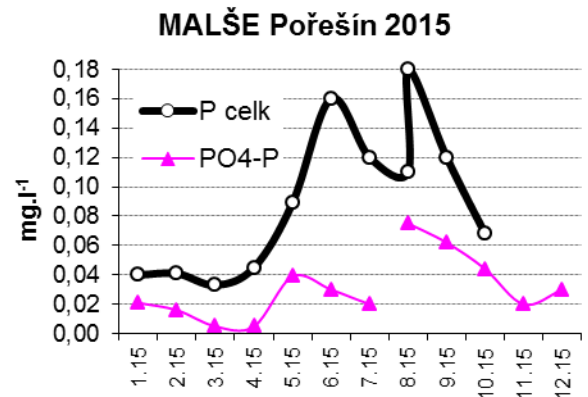
INFLOW II.

WORSE WHEN SOURCES ARE NEAR THE RESERVOIR

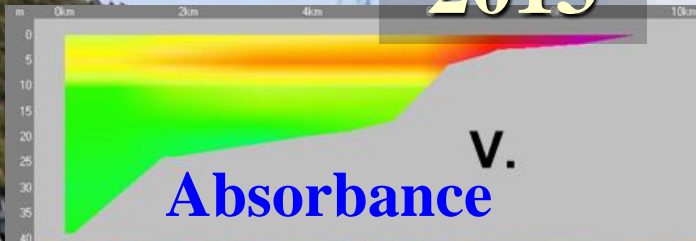
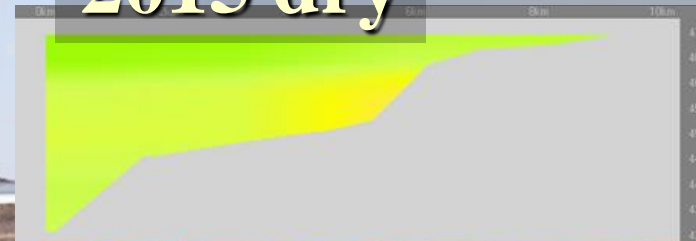
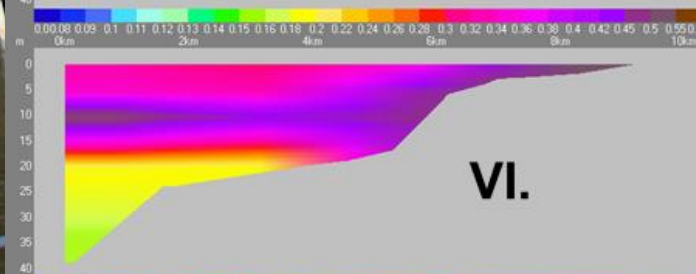
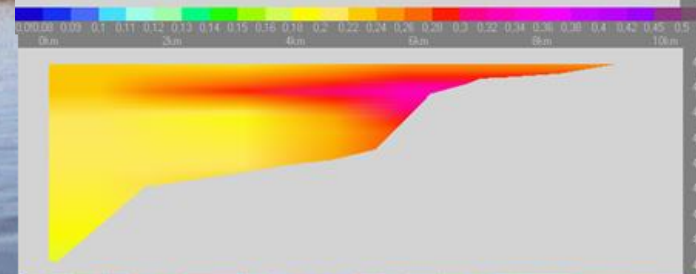
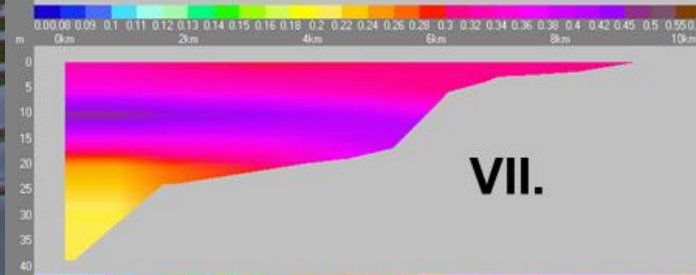
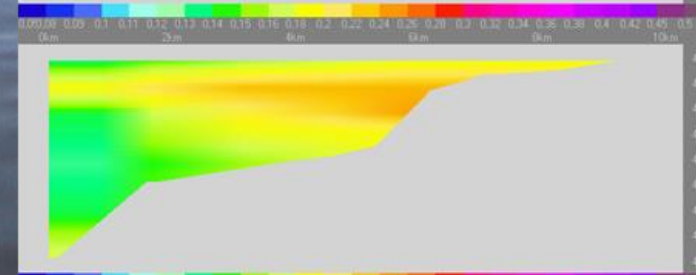
↓ loads of humic substances

2013

2015 dry

Lower P loads

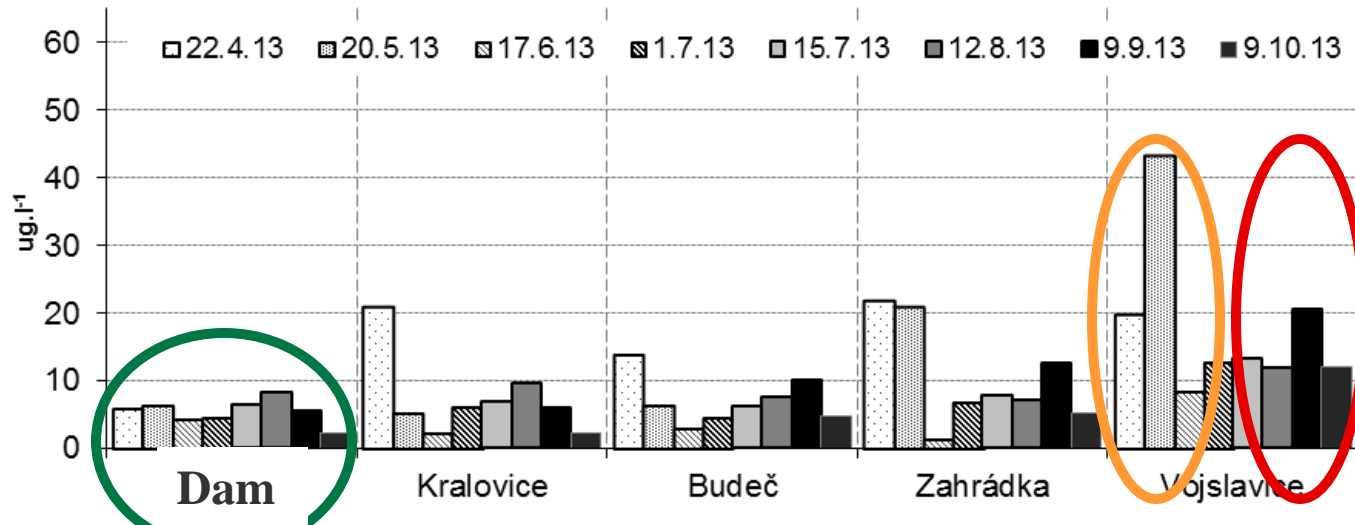
LONGITUDINAL PROFILE: EPILIMNION 2013 wet

long, canyon shaped reservoir (Švihov, drinking water res.)

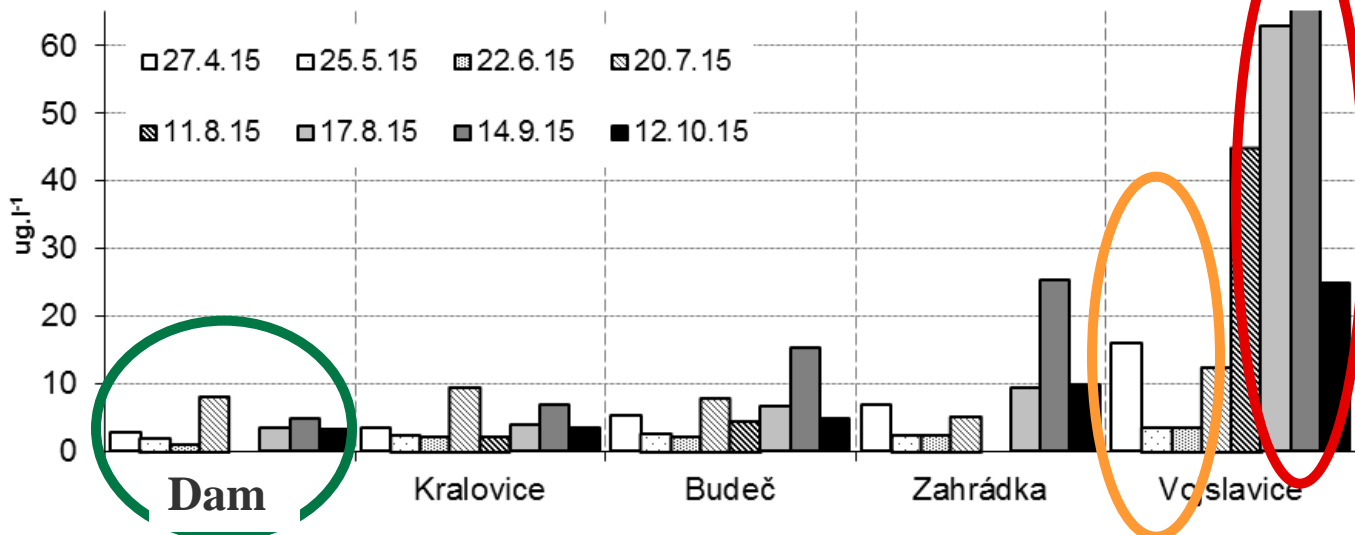
LONGITUDINAL PROFILE: EPILIMNION 2015 dry

More pronounced eutrophication effects in upper parts, better situation near the dam

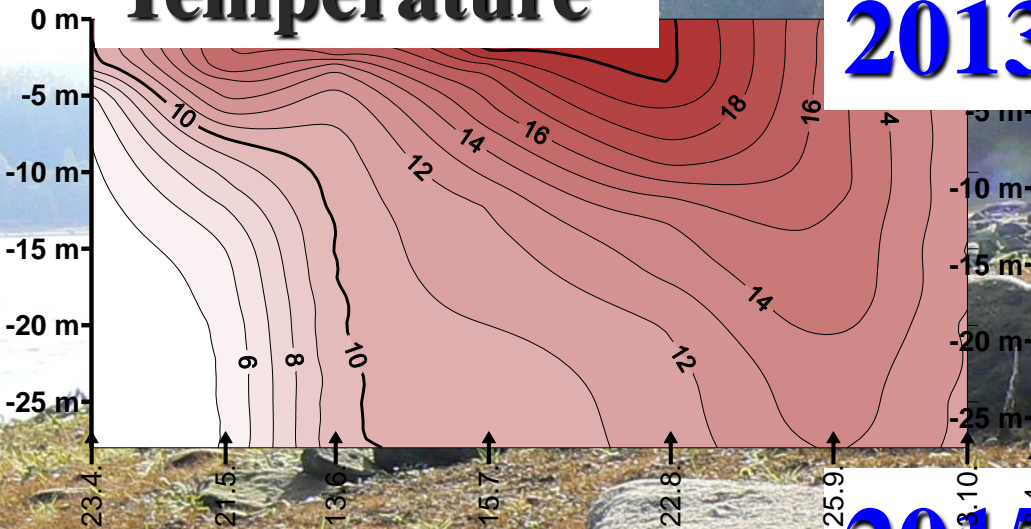
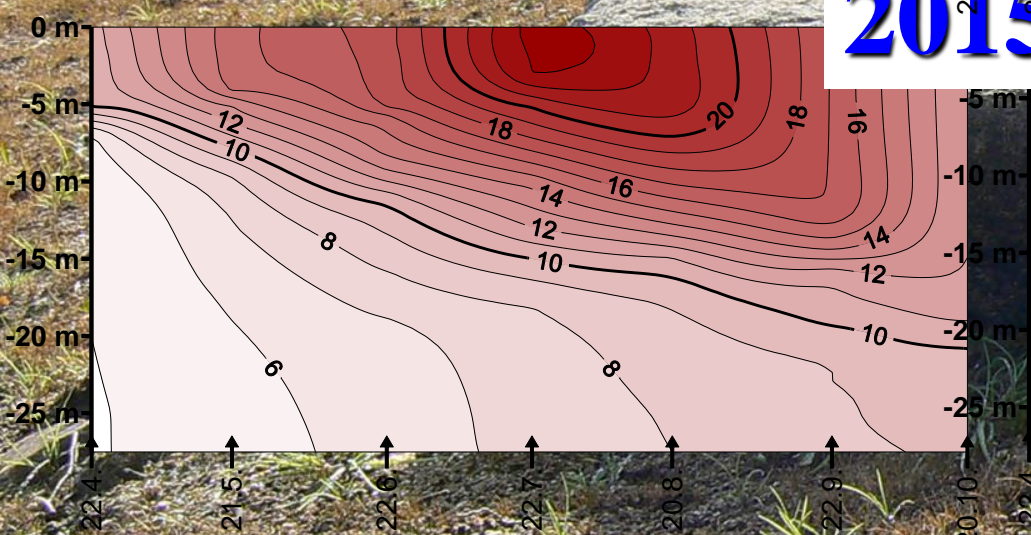
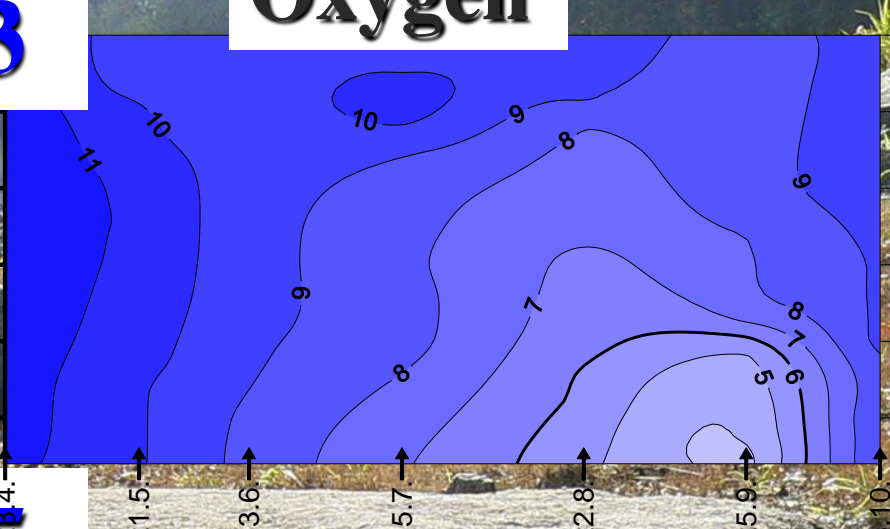
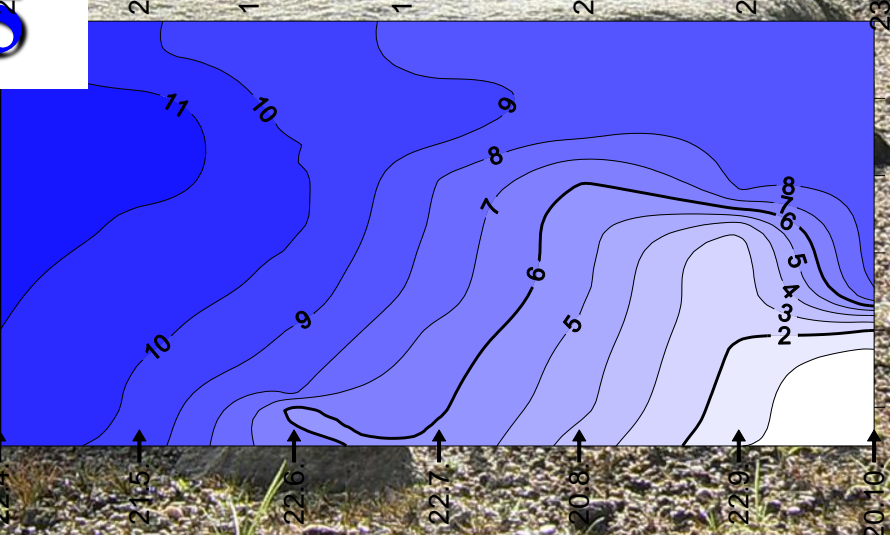
STRATIFICATION

Temperature

Oxygen

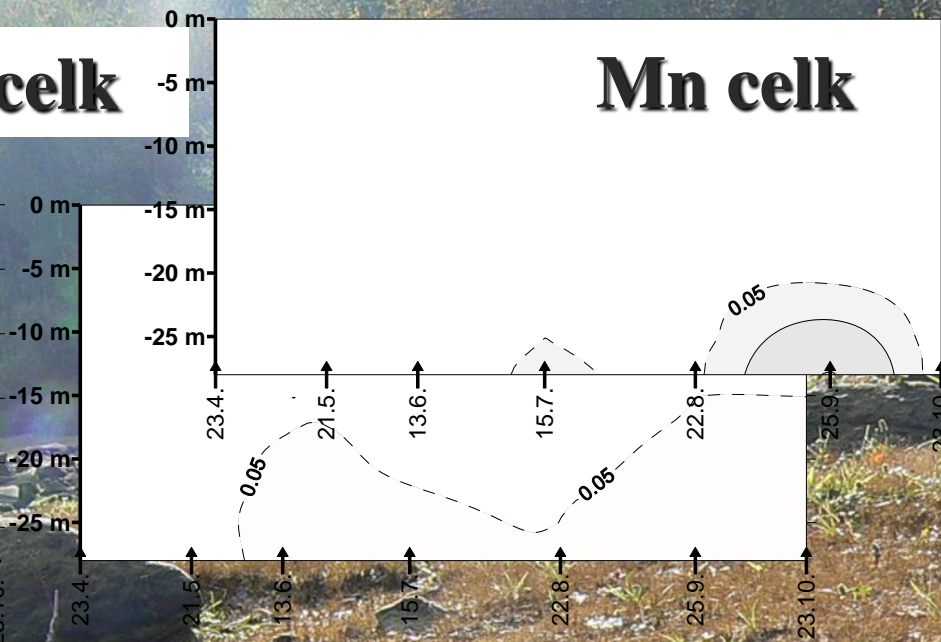
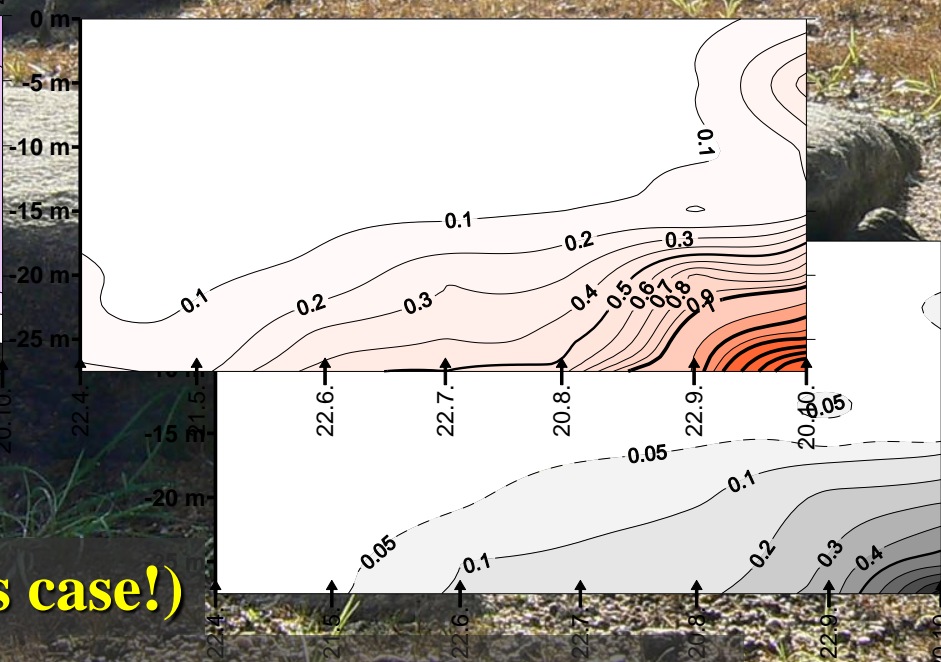
Fe celk

Mn celk

2015: potential risk of Fe + Mn, but not P (in this case!)

P was bound with Al and organic matter

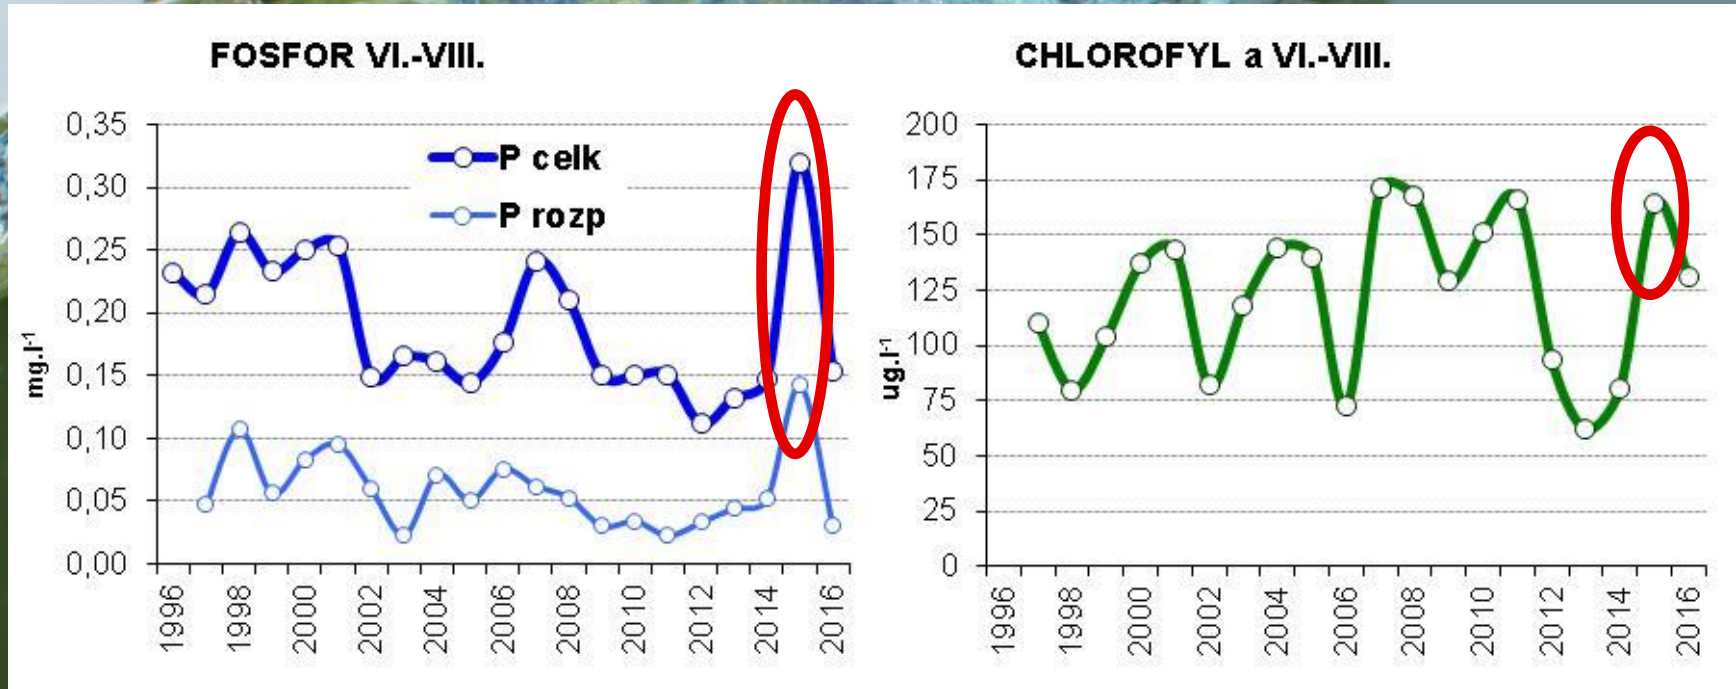
SHALLOW HYPERTROPHIC

**2015: Considerable internal P loading =>
WORSE SITUATION THEN USUALLY**

Extra high P concentrations, but not chlorophyll because phytoplankton biomass was limited by light, not by P

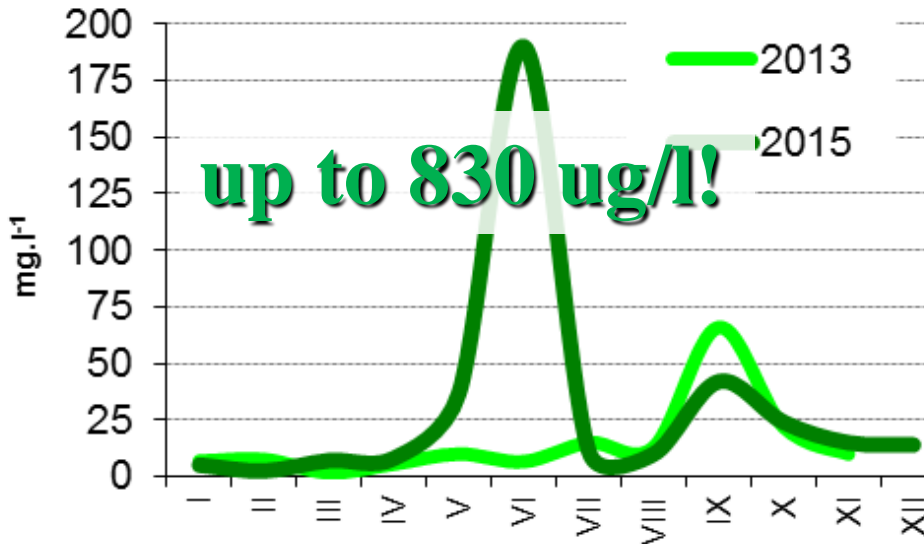
Chlorofyl a 2013/2015, směsné

2015: more stable stratification
 => worse O₂ conditions =>
 internal P loading => MUCH
 WORSE SITUATION!

Development of *Vacuolaria*
 bloom => disaster for
 waterworks
