A small guide through water management risks due to lack of water in north-eastern Bohemia

Petr Ferbar

Prague 18.10.2018 (Hotel Duo) – MGS 2018

Extreme hydrological events (Elbe River Board)

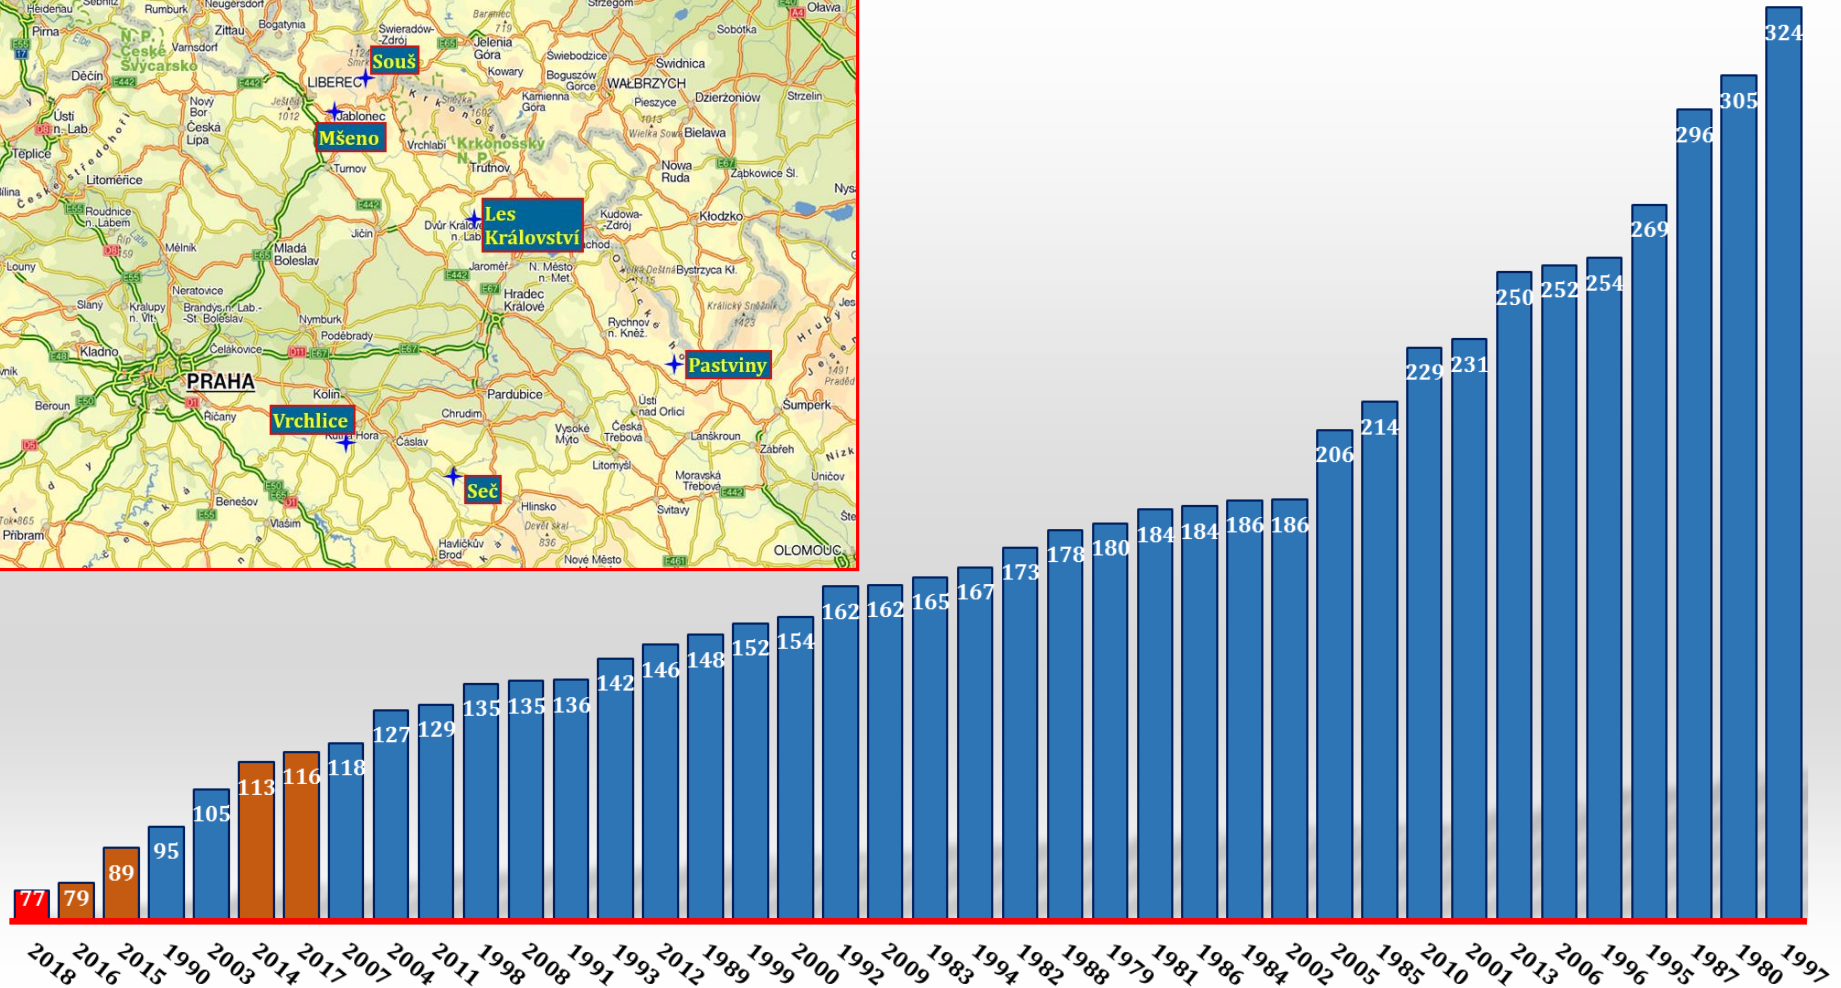
Growth chart year over year comparisons for cumulative volume of the inflows to six reservoirs managed by the River Elbe Board during the growing season

Growing season: 15th April – 15th September

Tested years: 1979 - 2018

SIX RESERVOIRS 1979 - 2018 (Cumulative volumes of the inflow/mil. m³)

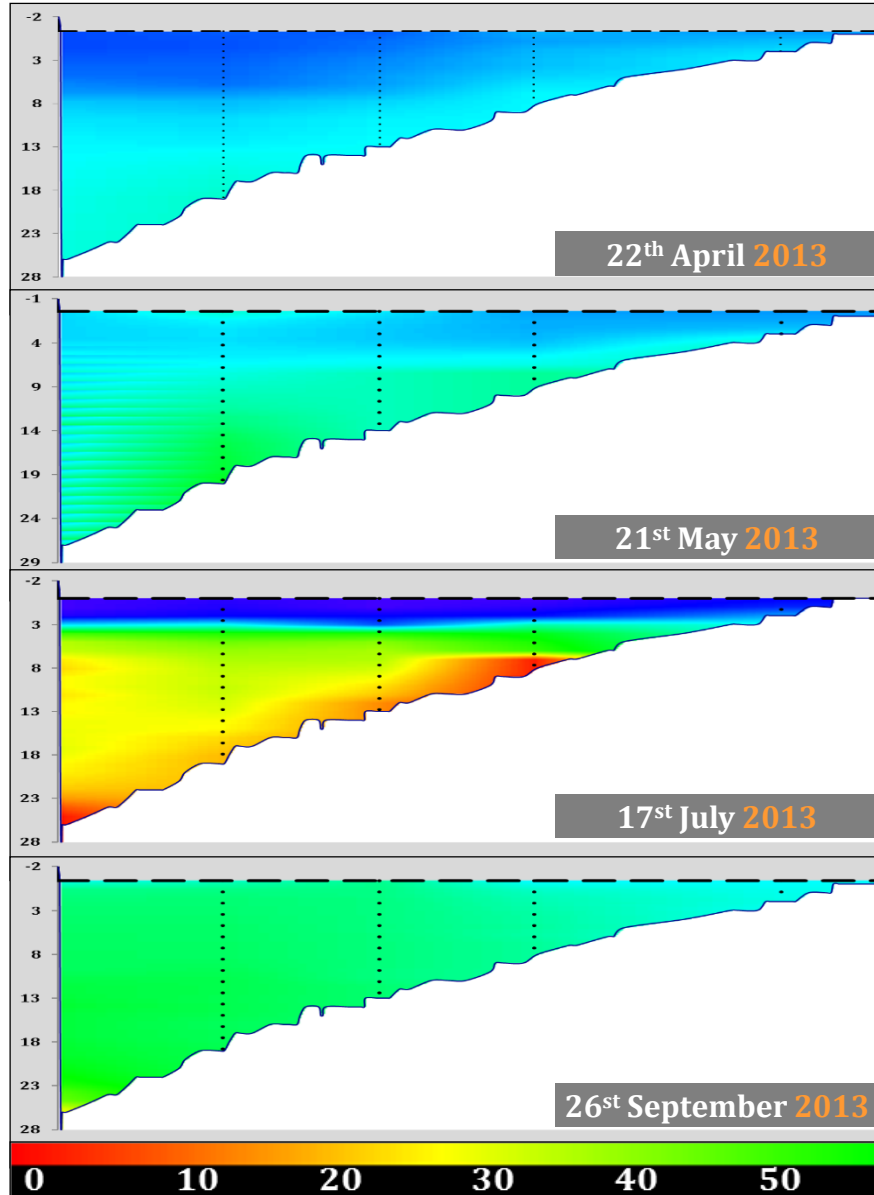
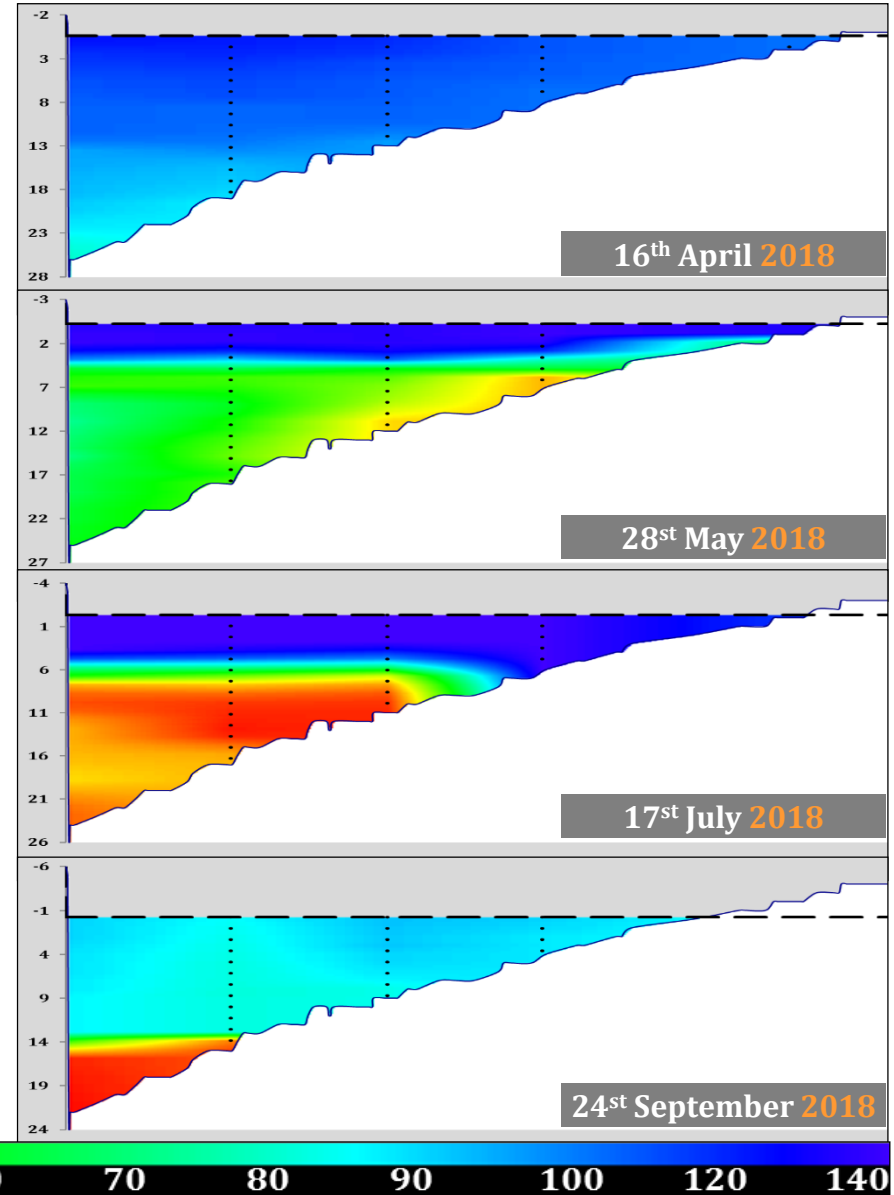
Seč reservoir – longitudinal profile – development of oxygen (%)

2013 – wet year (ordinary precipitation)

2018 – dry year (little precipitation)

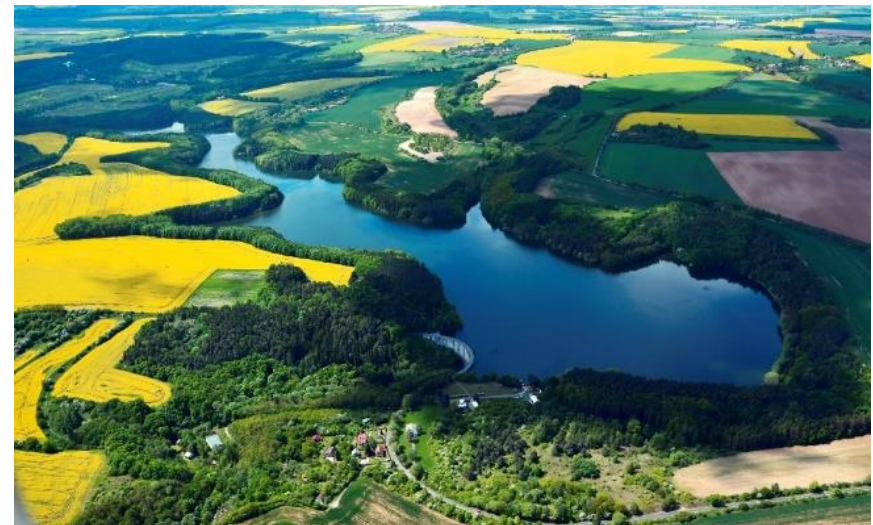
Quality monitoring on the surface water level (horizontal view)
Vrchlice reservoir (2018)

The presence of green algae and cyanobacteria concentration of chlorophyll-a ($\mu\text{g/l}$)

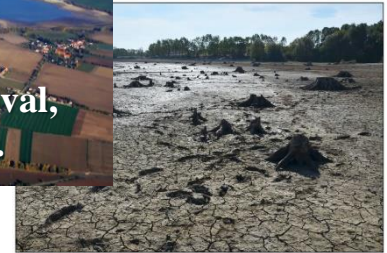
Rozkoš reservoir – increase the storage space by sediment removal, reflections about water transfer.

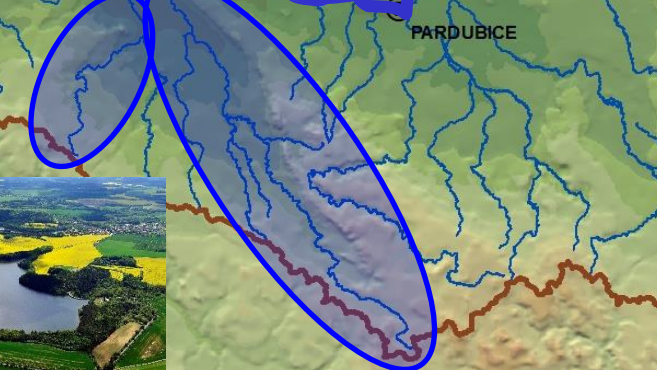
Case study: Water catchment area Doubrava and Vrchlice... evaluation of water reserves, search for new water resources.
