# The results of inspection activities of the Czech Environmental Inspectorate (CEI) in investigating the elevated PCB values in Elbe river and repair of the state

RNDr. Zdeňka Vaňková, Ing. Lubor Bednář, Mgr. Radek Tonner

6. 12. 2017

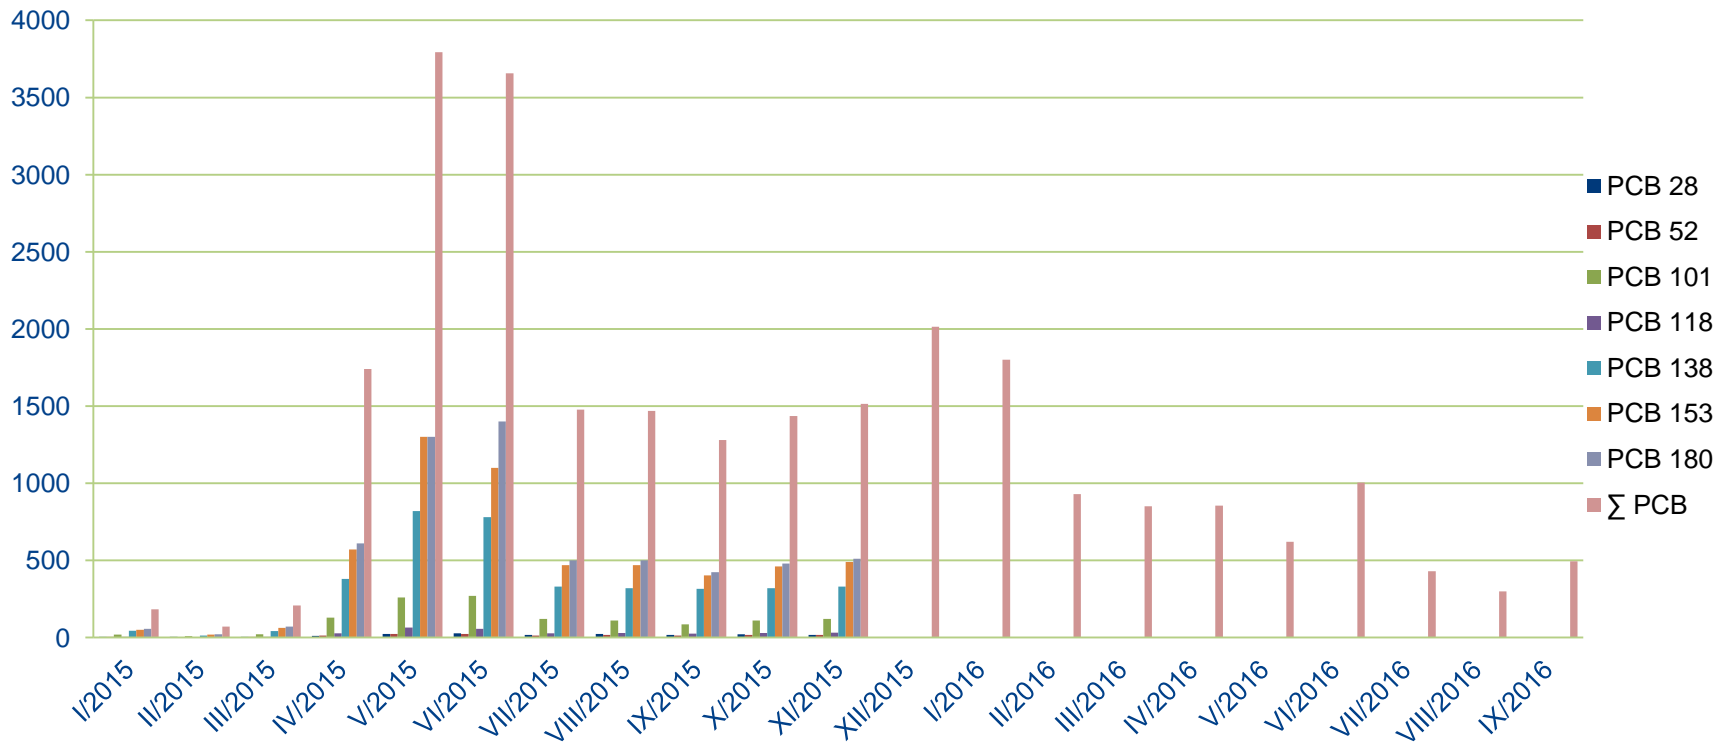
Labe Decin Measurement Station: PCB Content ( $\mu\text{g}/\text{kg}$  dry matter) in monthly collected samples of sedimentable suspended solids

- From April 2015, a significant increase in PCB concentrations in the hundreds to first thousands of  $\mu\text{g}/\text{kg}$  with a maximum of **3,793  $\mu\text{g}/\text{kg}$**  in May 2015 was noted in mixed sedimentable suspended solids samples.

- In July 2015, the PCB content dropped to about half the value of the maximum findings, the negative state continued throughout the rest of the year 2015, when a slight increase in the value probably occurred due to the increasing flows in the Elbe at the end of the year.

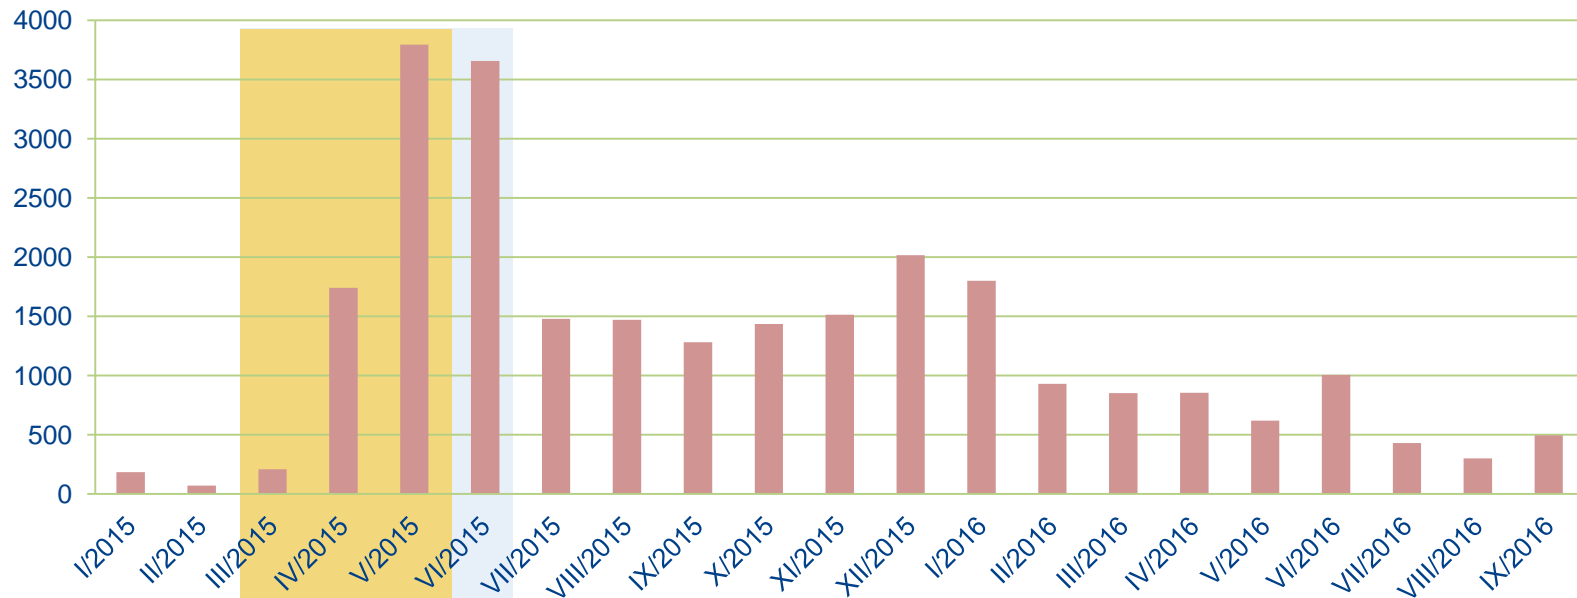
**Labe - Děčín Measurement Station: The content of  $\Sigma$ PCB ( $\mu\text{g}/\text{kg}$  dry matter) in monthly collected samples of sedimentable suspended solids compared to the realized activities on the Elbe River in Ústí nad Labem**

PROFICOLOR, a limited liability company, carried out the removal of old paint on the railway bridge

Povodí Labe, State Enterprise, realized extraction of sediments in the Elbe river stream from the locks Střekov, railway bridge to the Marian Bridge

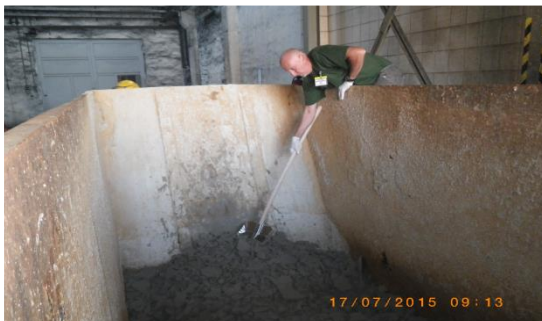
WWTP Ústí nad Labem – Neštěmice

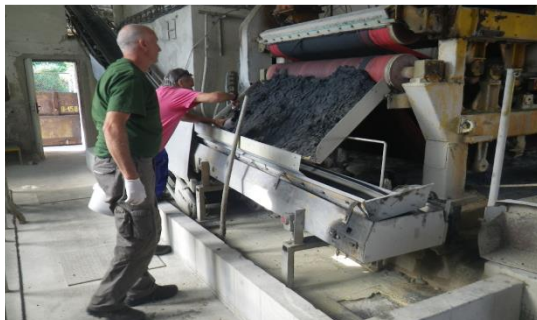
WWTP Oleochem, a.s. Ústí nad Labem-Střekov

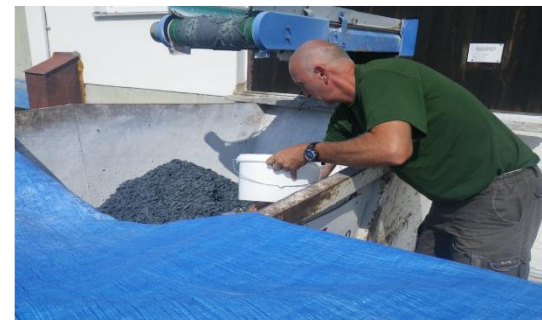
WWTP Water Glass, a.s. Ústí nad Labem -Neštěmice

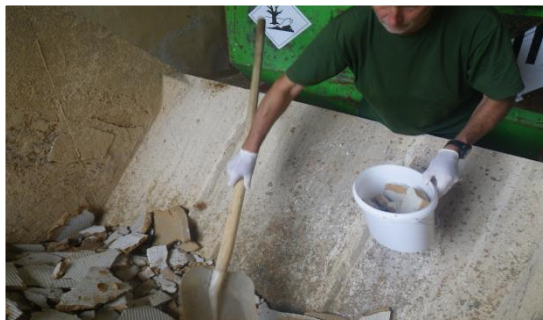
WWTP BWWTP resin Association for Chemical and Metallurgical Production, a.s.

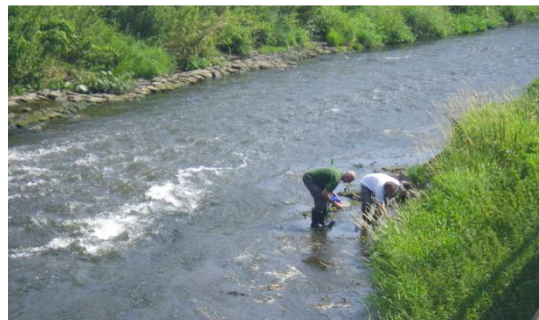
Bílina river cca 100 m under the outflow of Klíšský potok

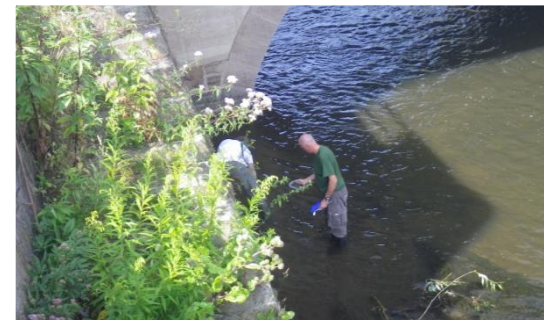
Bílina river mouth to the Elbe

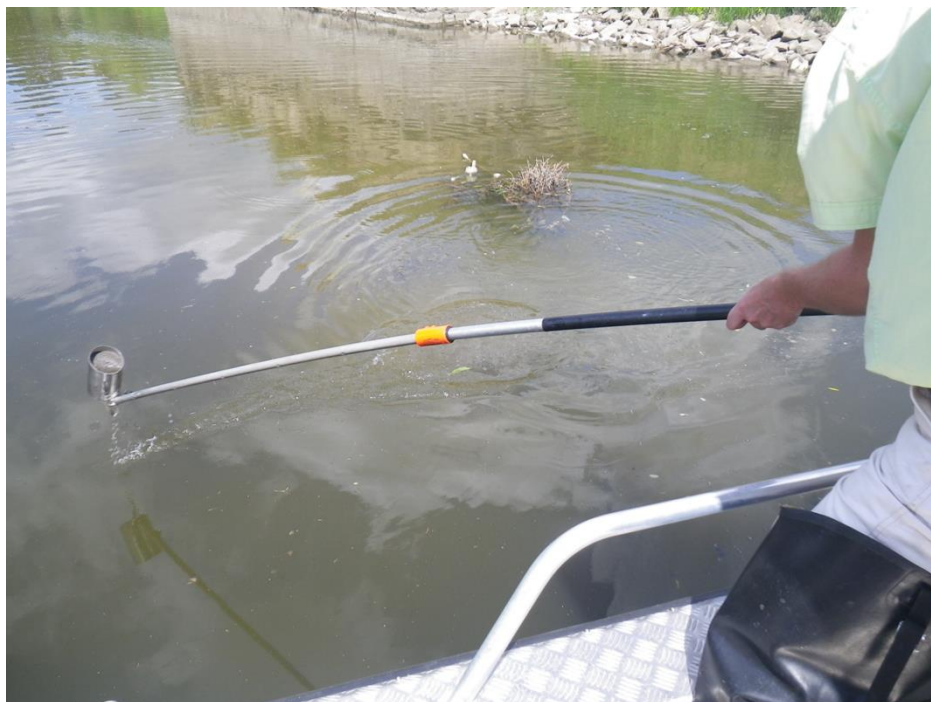
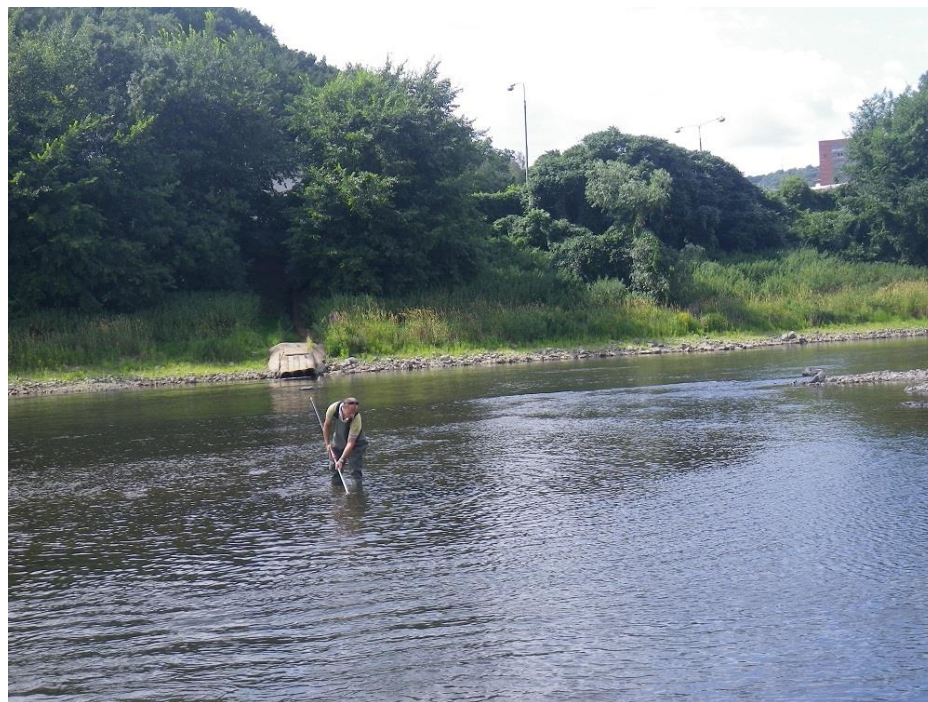
Sampling of sediments on 20.7.2015

- Sampling of fresh sediments was carried out on 20.7.2015 from the ship of Povodí Labe, state enterprise, and from the banks of the Elbe in the places where the sediments occur and the expected source of pollution.
- Chemical analyses were carried out by an accredited laboratory of Povodí Labe, a state enterprise.

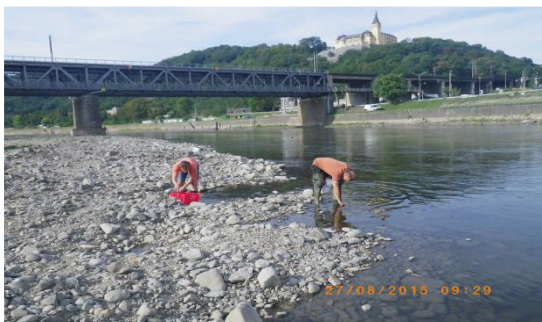
Sampling of the sediment extracted during extractions - under the railway bridge

On August 27, 2015, an accredited laboratory of the Povodí Labe, a state enterprise, took samples of the sediments from the extractions deposited in the Elbe River under the railway bridge and under the Marian bridge.

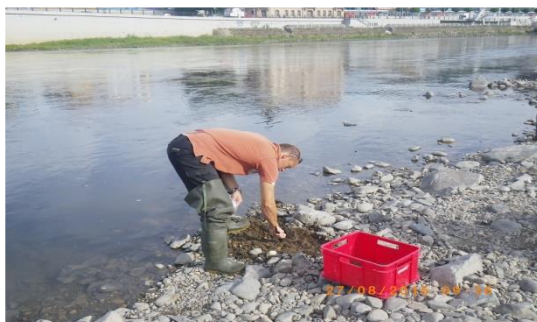
Sampling of the sediment extracted during extractions - under the railway bridge

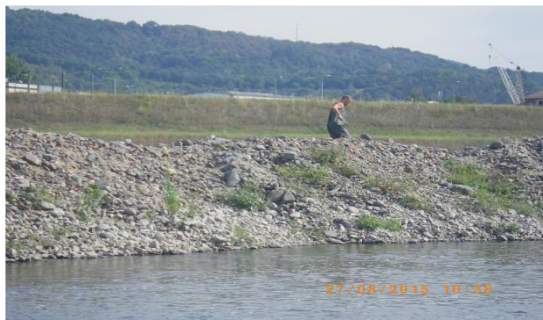
Sampling of the sediment extracted during extractions - under the Mariánský bridge

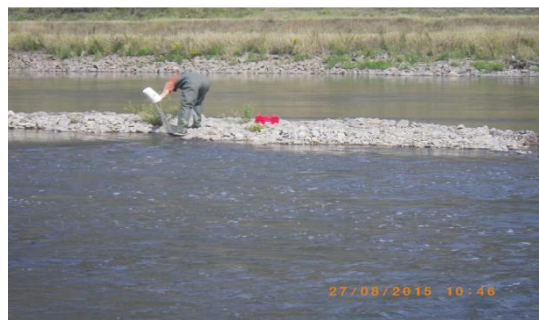
Sampling of the sediment extracted during extractions - under the Mariánský bridge

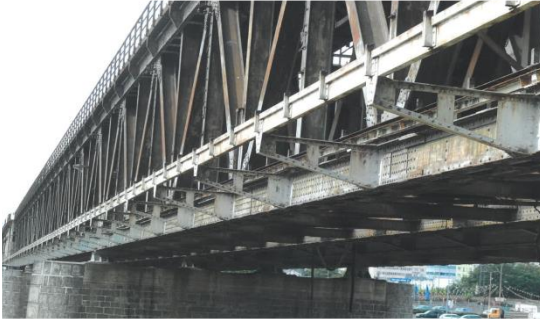
Railway bridge– original state

- Pollution of sedimentable suspended solids by PCBs in the Elbe was partly due to the leakage of abrasive material (siliceous sand) containing PCB, which was used to remove the original coating of the railway bridge in Ústí nad Labem. The repair was carried out by PROFICOLOR, a limited liability company.
- During the time the bridge was under repair, the used abrasive was trapped by rubber fabric and canvas cover and continuously transported away, but some of the material in the form of dust got into the air and then into the surface waters of the Elbe and to the terrain.
- The original paint of the bridge from the 1960s included PCBs.

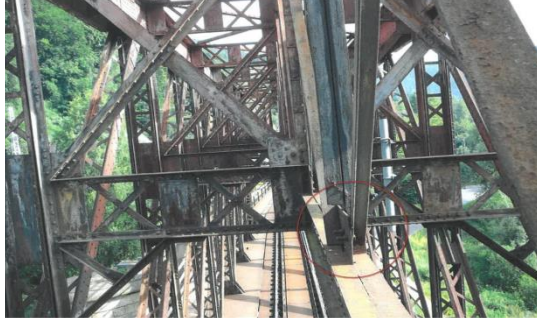
Railway bridge– original state

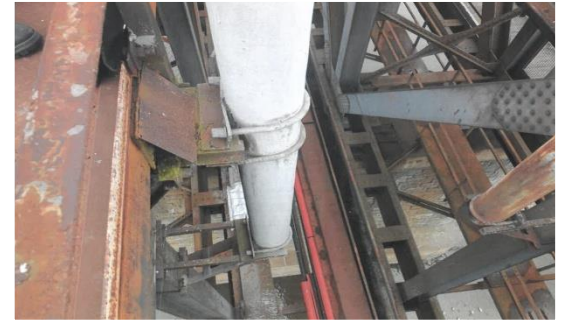
Railway bridge– original state

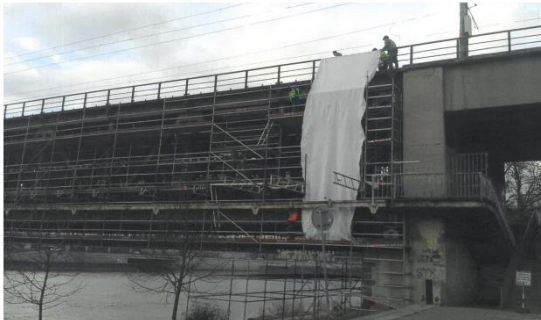
Railway bridge– during repair

- when repairing the railway bridge, sand dropping, containing the original anticorrosion coating with PCBs from the blasted surface of the railway bridge construction into the Elbe watercourse and the terrain, was not sufficiently secured.

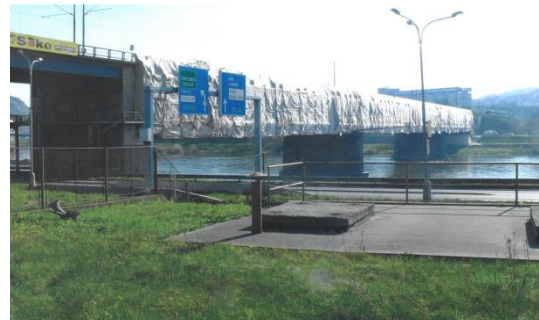
Railway bridge– during repair

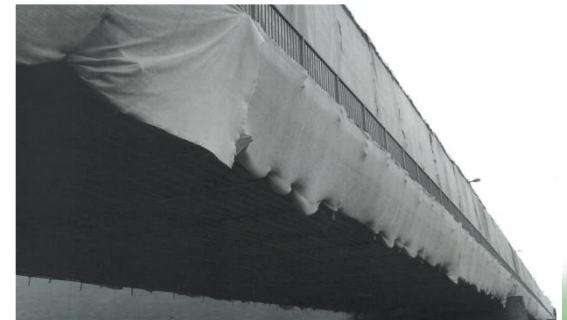
Railway bridge– during repair

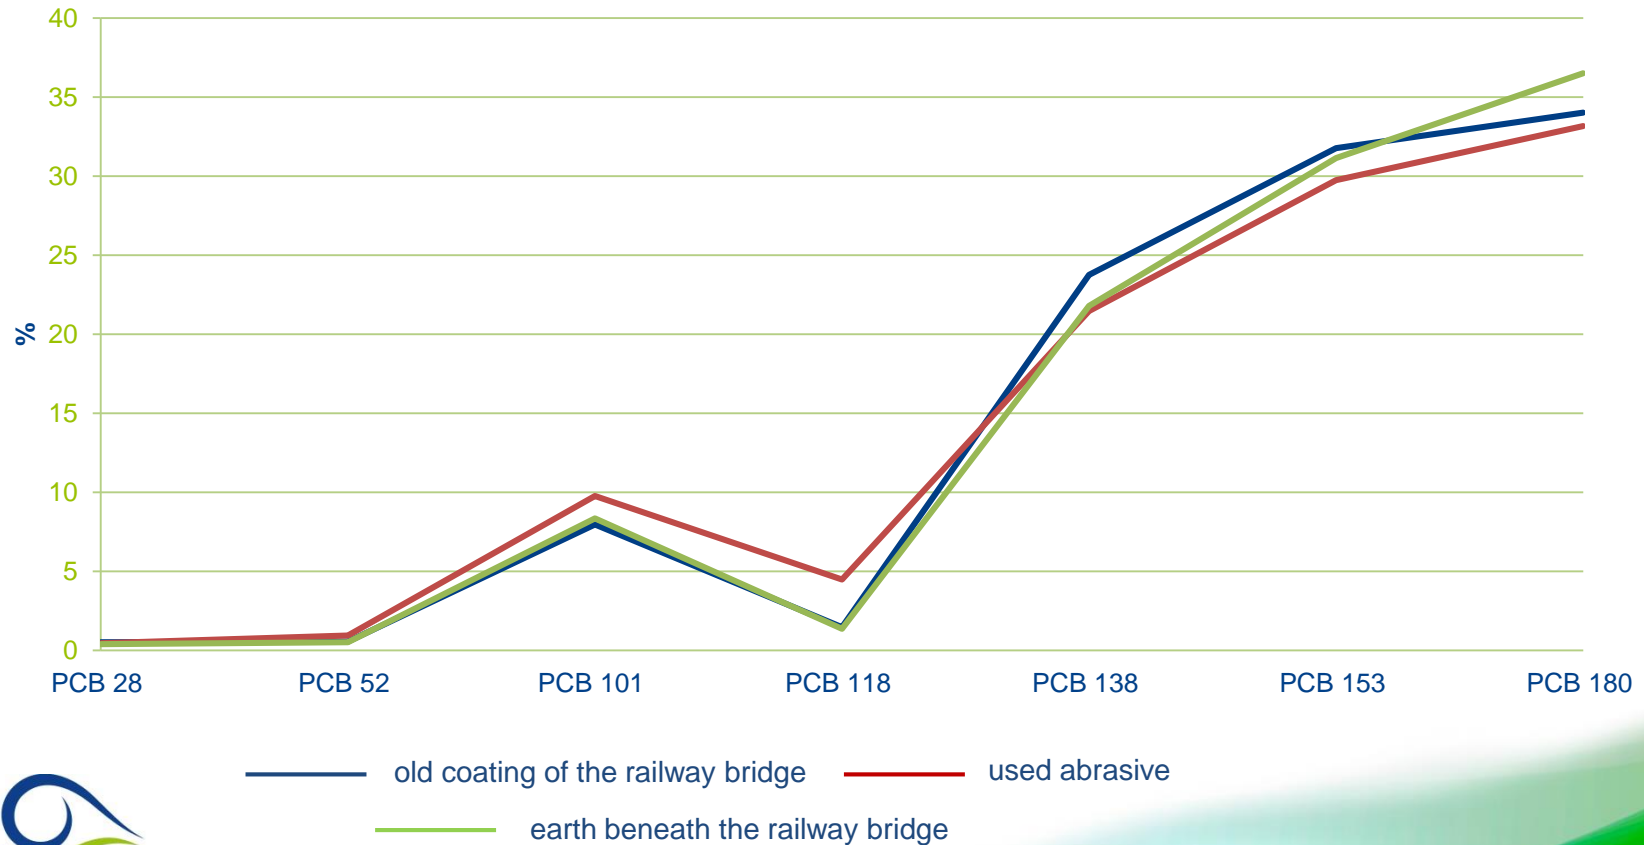
From the graph below, it is clear that the percentage of PCB congeners is the same in the case of the old coating of the railway bridge, in the used PCB - contaminated abrasive from the blasting of the railway bridge and the ground beneath the railway bridge.

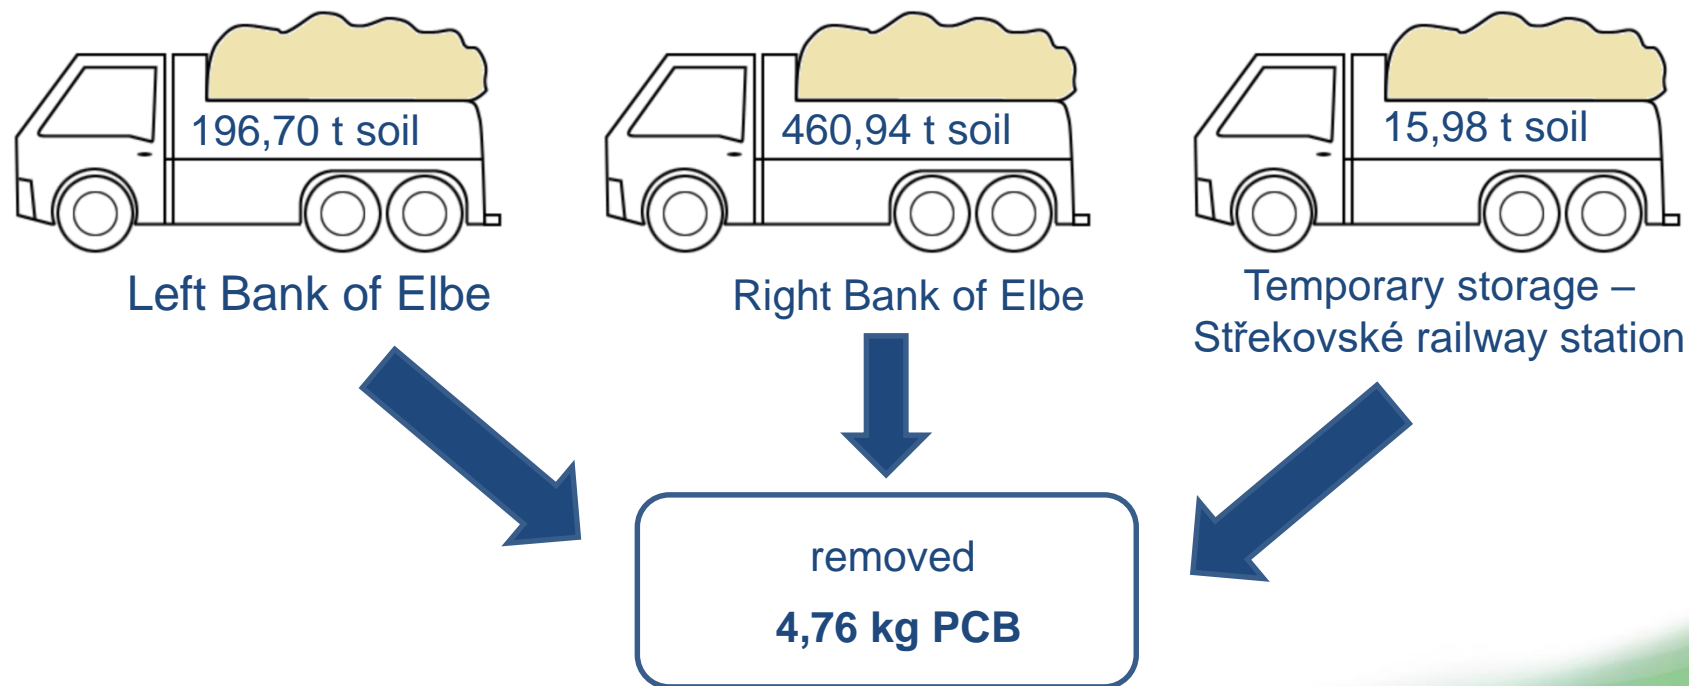
## Amount of PCB removed by decontamination work

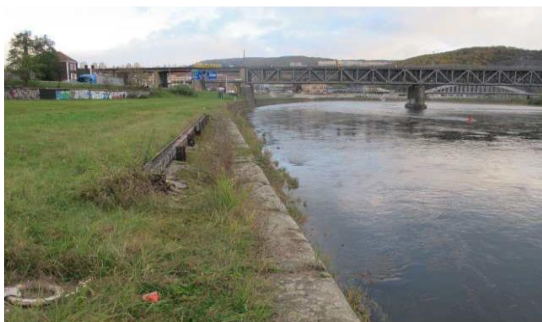
Left bank – before decontamination

Based on the confirmed contamination of PCBs in bank areas under the railway bridge to a distance of 50 m on each side of the axis of the railway bridge at a depth of 0 to 10 cm from landscaped terrain and at the site of the original temporary storage of used abrasive at building At the Station no. 13/1587 in the area of Střekovský railway station, DEKONTA, PLC decontaminated the area by displacing the contaminated soils.

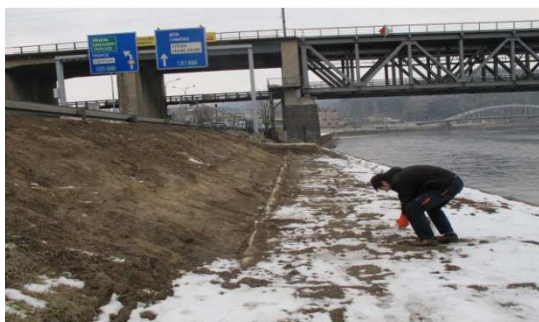
Left bank – after removal of contaminated soil, final sampling

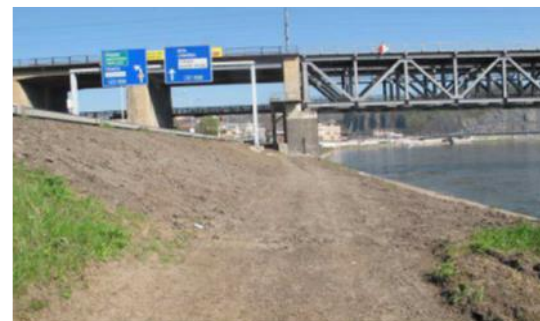
Left bank – after decontamination

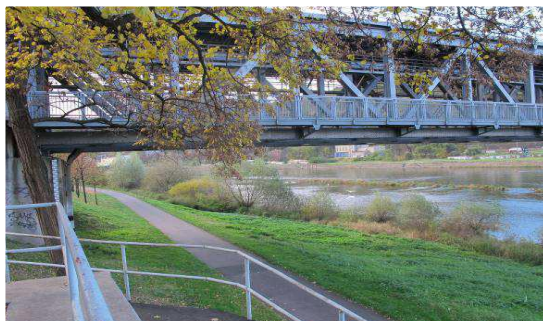
Right bank – before decontamination

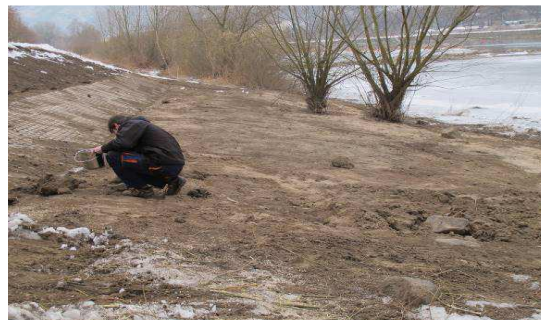
Right bank – after removal of contaminated soil, final sampling

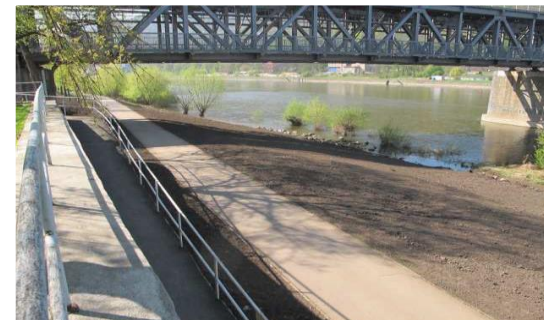
Left bank – after decontamination

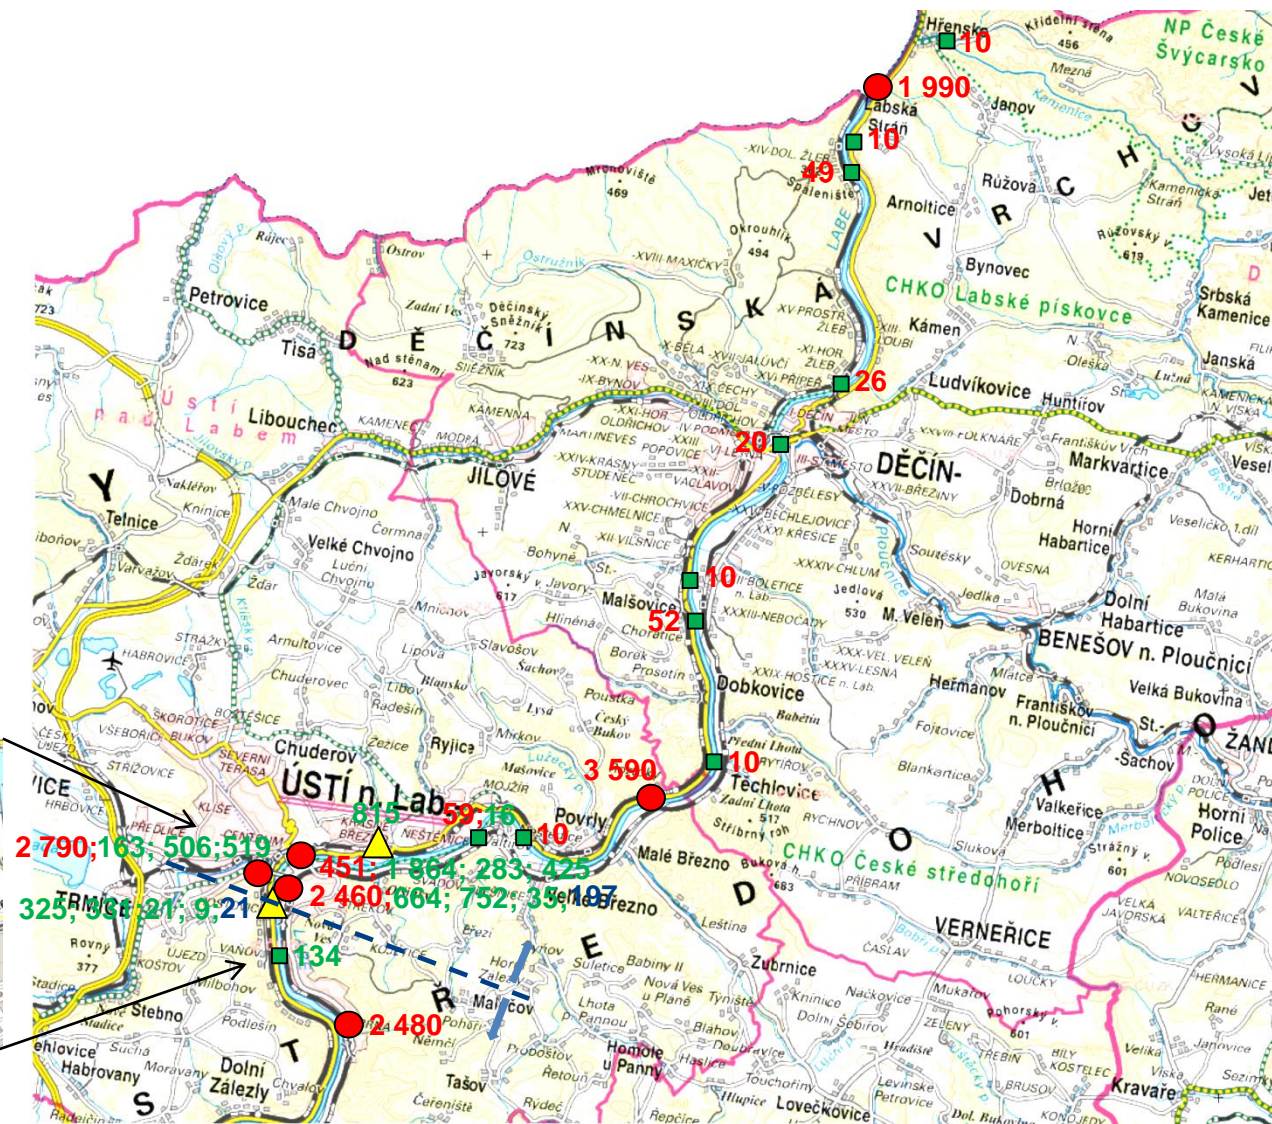
# Total content of PCBs in Elbe sediments

$\Sigma$  PCB ( $\mu\text{g}/\text{kg}$  dry matter)

- < 10 – 219
- ▲ 220 – 1 499
- > 1 500

- Increased concentrations of PCBs in sediments form isolated enclaves, including areas with a significantly lower PCB content.
- The representation of individual PCB congeners in samples taken does not allow the resolution of any individual sources of pollution. The exception is the Bílina river sediments with a relatively higher proportion of PCB-28 and PCB-52.
- Elevated concentrations of PCBs were also found in the river sediments of the Elbe beyond the railway bridge up the river stream. Suspended solids with PCBs could be released from deeper layers of the river bed while extracting shipping trajectory and elevated levels of PCBs in sediments were caused by its remobilization.
- Part of the increased values of PCBs is due to the reckless use of these toxic substances in the past and their long-term storage in the river sediments of the Elbe.
