Magdeburský seminář o ochraně vod/Magdeburger Gewässerschutzseminar

Long-term sediment contamination in the Elbe River floodplain, and an example of a limnological study

**RNDr. Dagmar Chalupová, Ph.D., Mgr. Lucie Beranová,
prof. RNDr. Bohumír Janský, CSc.**

**Faculty of Science, Charles University
Department of Physical Geography and Geoecology**

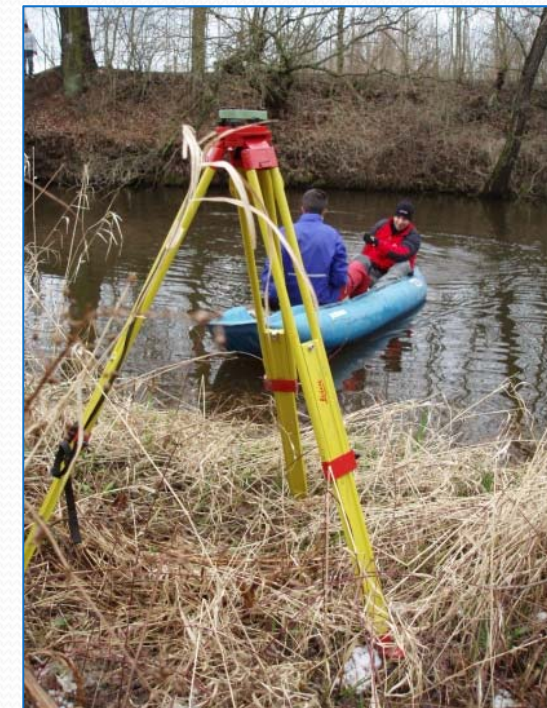
Complex limnological research

- hydrological regime of oxbow lakes
- bathymetric measurements
- water quality – physical parameters in water column
- water quality – chemical analyses
- hydrobiology
- sediment quality – granulometry, chemical analyses

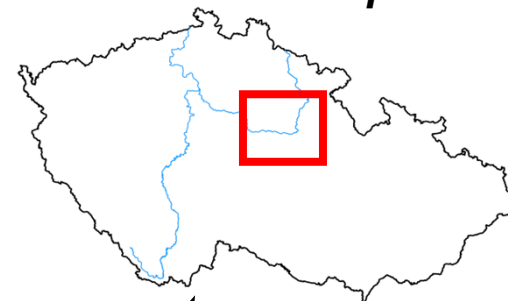
Study sites 1.

The Czech Republic

main sources of industrial pollution

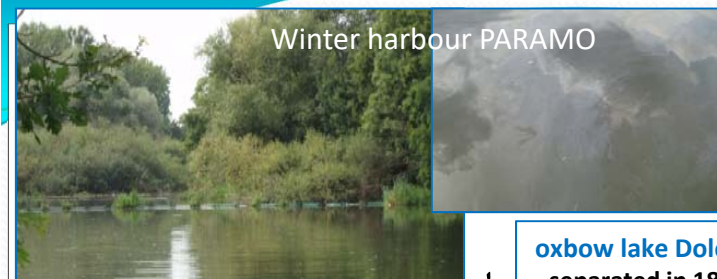
oxbow lake Doleháň
 - separated in 1853
 - 1.5 km long channel, pipe
 - industry of Kolín (Lučební, Draslovka chemical plants, refinery KORAMO), agrochemicals

oxbow lake at Rosice (ELSA)
 - meander divided by a dam with a pipe
 - western part connected to the river
 - waste pond in the inner part of the meander
 - Synthesia chemical plant, village

oxbow lake at Náměčice
 - separated in the 1920s
 - channel, overflowing of flood dams
 - agrochemicals, village, gardening colony, industry of Hradec Králové (FOMA – photographic industry), Opatovice power plant

Oxbow lake at Lžovice
 - separated in the 1970s
 - connected in the south
 - industry of Pardubice region, village, agrochemicals

Labiště beneath Opočíněk
 - separated in the 1920s
 - channel, overflowing of flood dams
 - industry of Pardubice region, agrochemicals, village
 - natural monument

Winter harbour PARAMO (ELSA)
 - connected in the west
 - Jesenčanský brook flowing from PARAMO refinery, gardening colony along the brook, agrochemicals
 - baffles in the lake

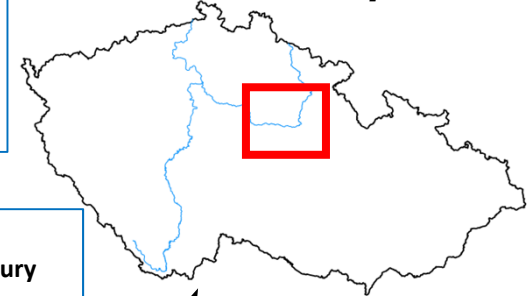
Study sites 2.

The Czech Republic

main sources of industrial pollution

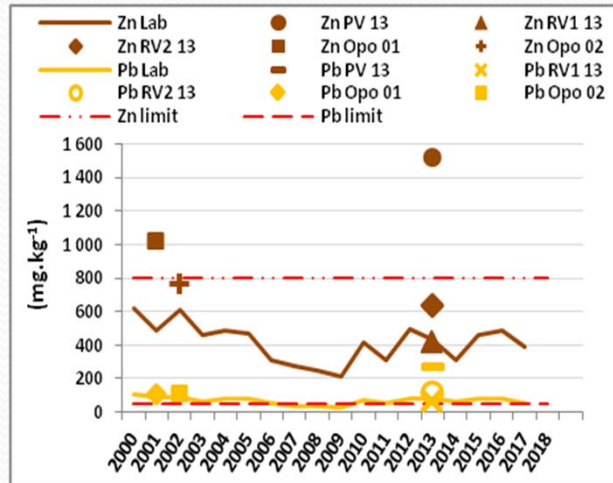
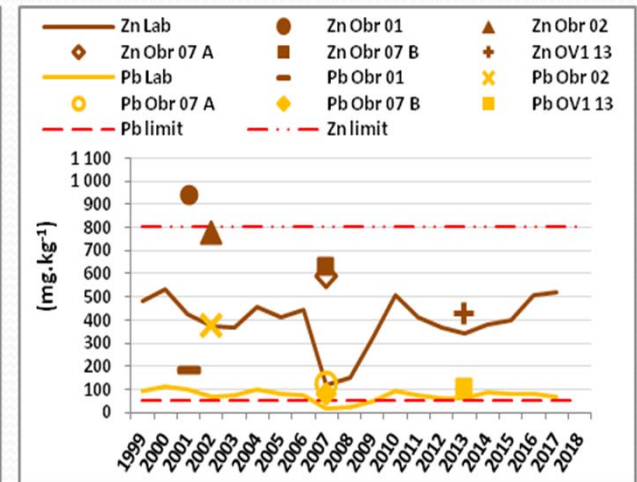
Comparison of the Elbe River monitoring profiles – Němčice, Valy, Lysá, Obříství (2000-2017)

- development of concentrations of Pb and Zn in the Elbe River in comparison with avg. concentrations in the cores

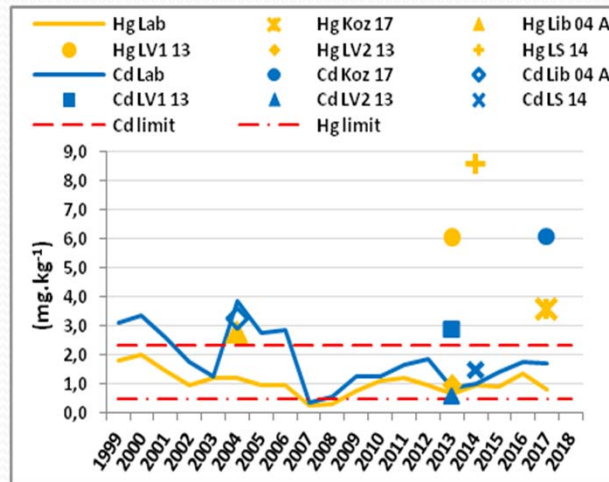
Comparison of the Elbe River monitoring profiles – Němčice, Valy, Lysá, Obříství (2000-2017)

- development of concentrations of Cd and Hg in the Elbe River in comparison with avg. concentrations in the cores

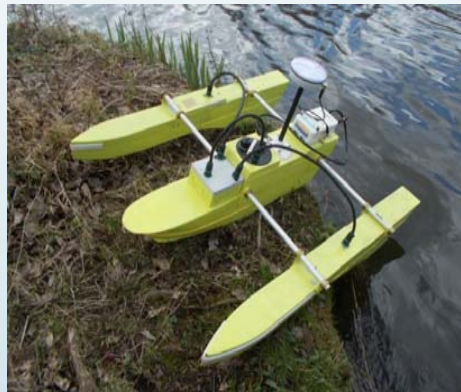
RiverSurveyor (photo L. Beranová)

- RiverSuveyor - depths of lake
- Bank line – Garmin GPS

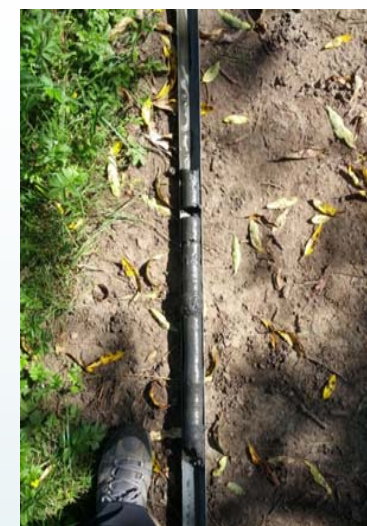
Sediment core (photo L.Beranová)

Classification EN ISO 14668-1

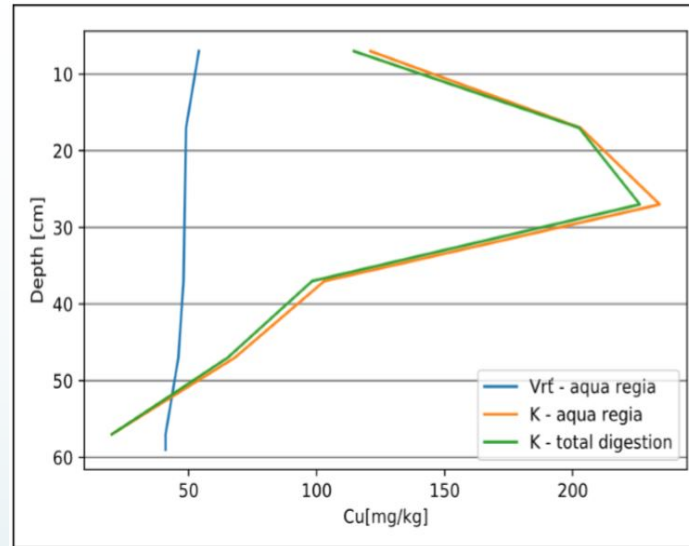
Concentration of Cu in sediments
