# FLOODS IN JUNE 2013

Jan Kubát

Czech Hydrometeorological Institute

# Project on Assessment of June 2013 Flood

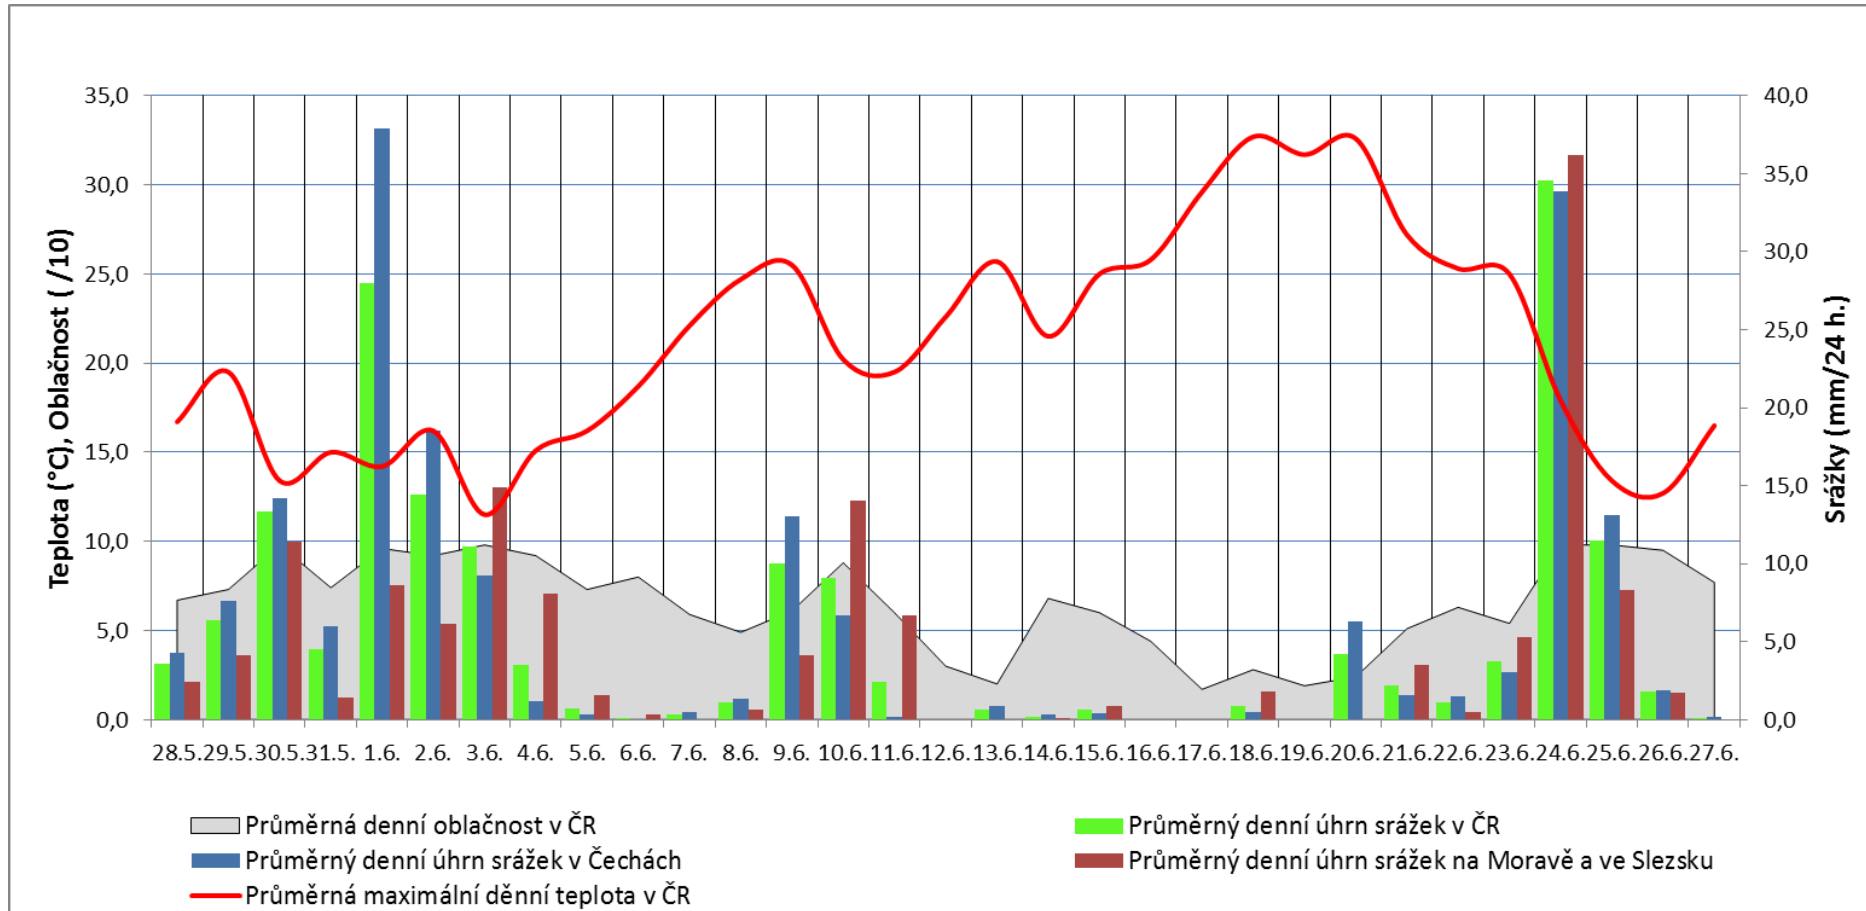
# Meteorological causes of floods

the first episode	29.5. – 3.6.	regional precipitation in Bohemia (mainly 1.- 2.6. > 100 mm on great area)
the second episode	9.6. – 11.6.	flash precipitation in several locations
the third episode	24.6. – 25.6.	regional precipitation in Bohemia and Moravia (mostly less than 100 mm)
		several days with tropical temperatures before

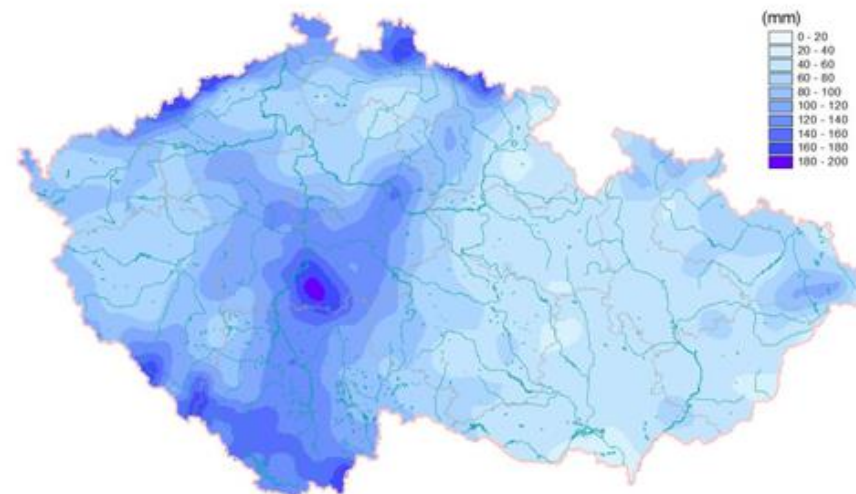
**Precipitation total from 29.5. to 5.6.2013**

**space mean nearly 100 mm in Bohemia (the Labe basin)  
about 150 mm in the centre south of Prague**

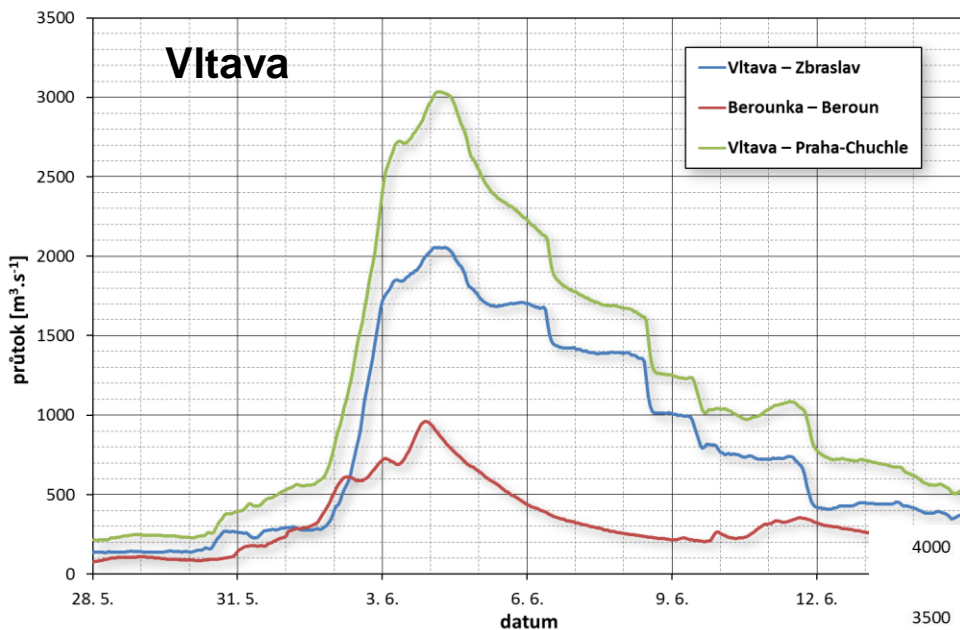
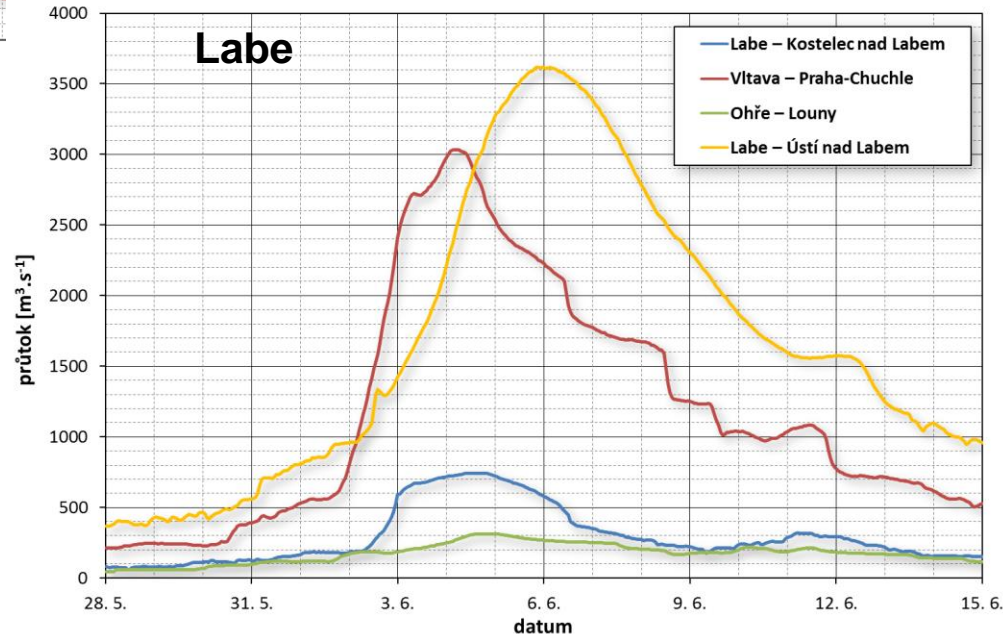
# Composition of flood waves on main rivers

Flood in	6/2013	8/2002
Vltava – Zbraslav	2100	3340 $\text{m}^3/\text{s}$
Berounka – Beroun	960	2170 $\text{m}^3/\text{s}$
Vltava – Praha Chuchle	3040	5160 $\text{m}^3/\text{s}$
ratio Vltava – Berounka	2 : 1	1,5 : 1
ratio of basin area	2 : 1

Flood in	6/2013	8/2002
Labe – Kostelec n.L.	744	530 $\text{m}^3/\text{s}$
Vltava – Vraňany	3080	5120 $\text{m}^3/\text{s}$
Vltava – Mělník	3640	5050 $\text{m}^3/\text{s}$
Ohře – Louny	314	175 $\text{m}^3/\text{s}$
Labe – Ústí n.L.	3630	4700 $\text{m}^3/\text{s}$
Labe – Děčín	3740	4770 $\text{m}^3/\text{s}$
ratio Vltava – Labe	4 : 1	9,6 : 1
ratio of basin area	2 : 1

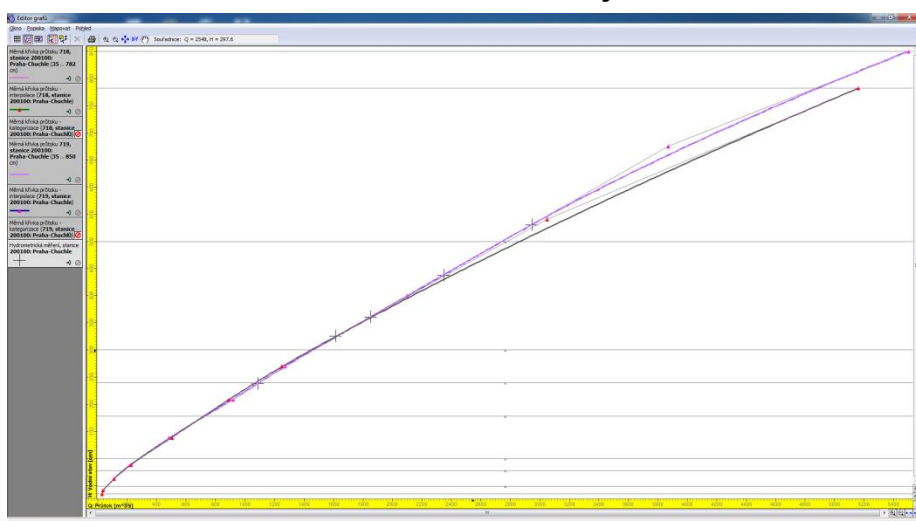
Adjustment of rating curve in Prague gauging station  
maximum discharge 3300 m<sup>3</sup>/s during the event  
3040 m<sup>3</sup>/s after adjustment

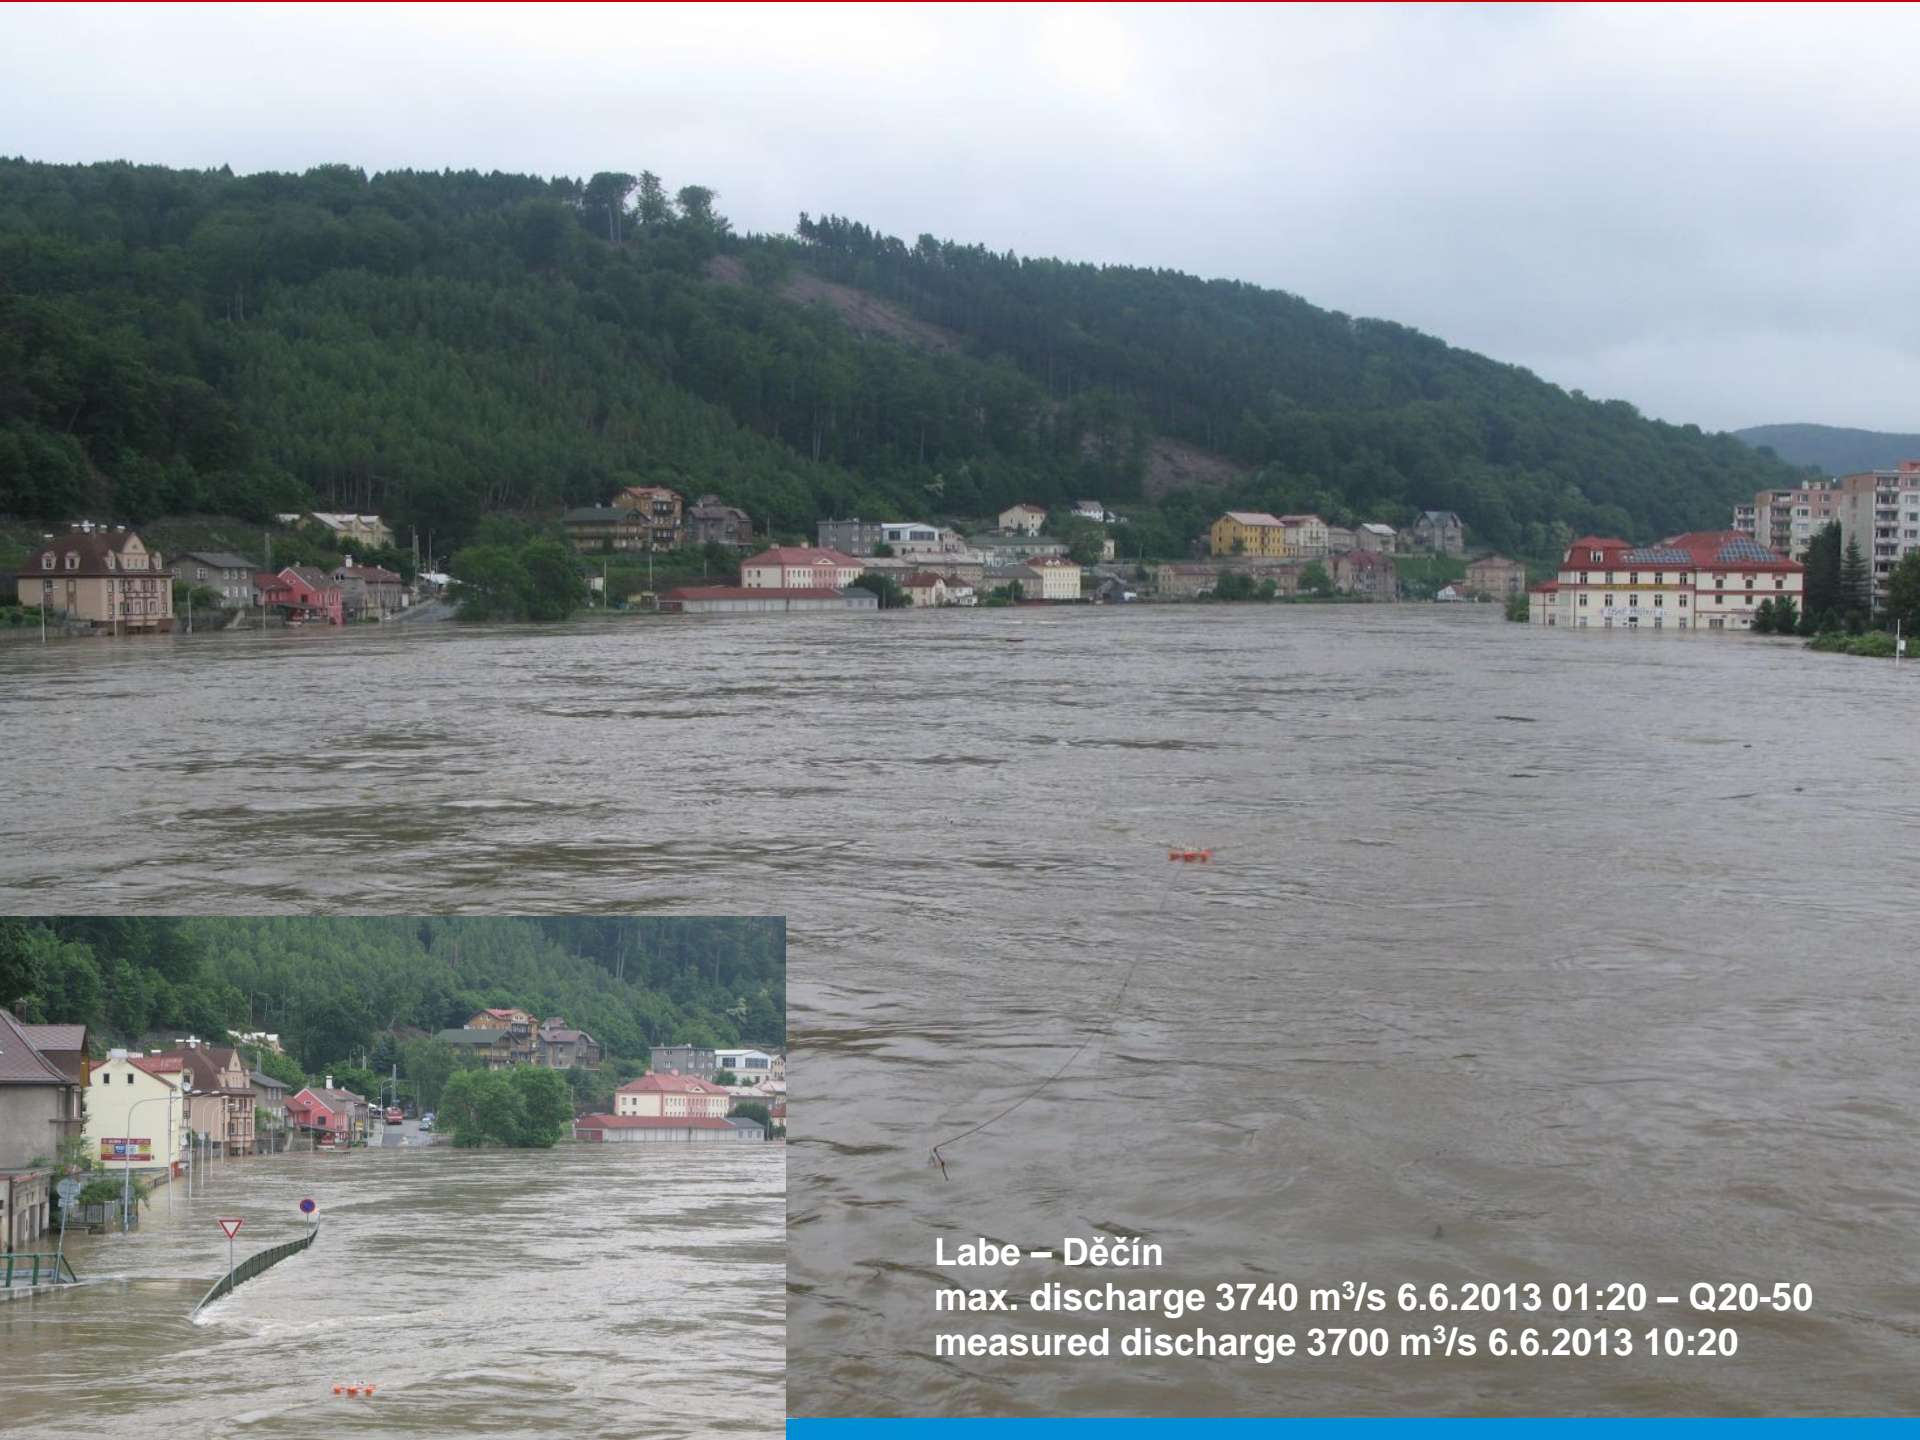
Labe – Děčín

max. discharge 3740 m<sup>3</sup>/s 6.6.2013 01:20 – Q20-50

measured discharge 3700 m<sup>3</sup>/s 6.6.2013 10:20

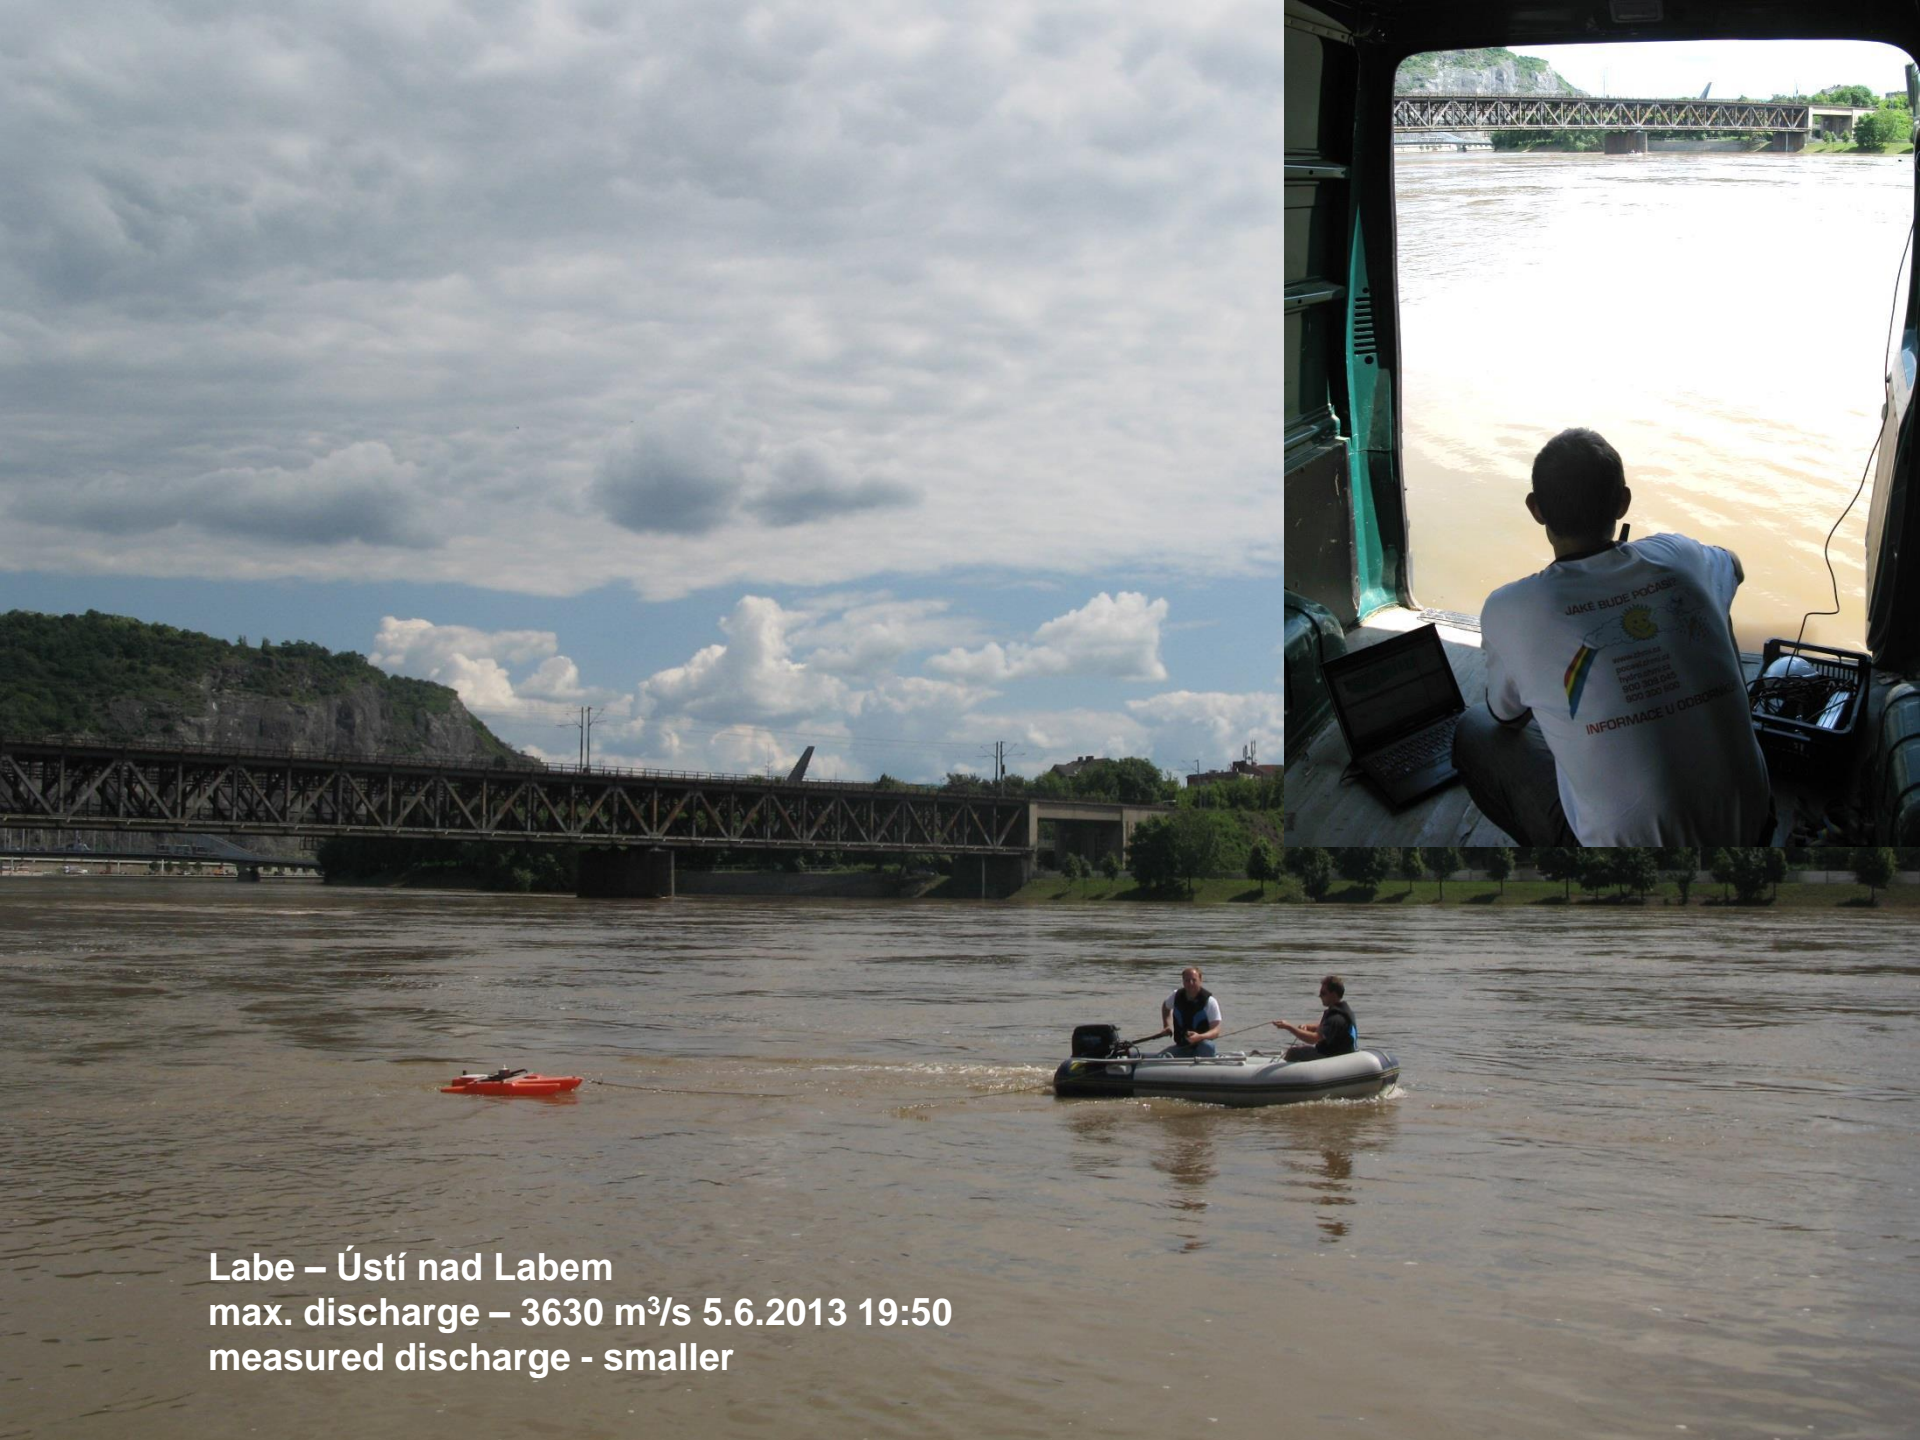
Labe – Ústí nad Labem  
max. discharge – 3630 m<sup>3</sup>/s 5.6.2013 19:50  
measured discharge - smaller

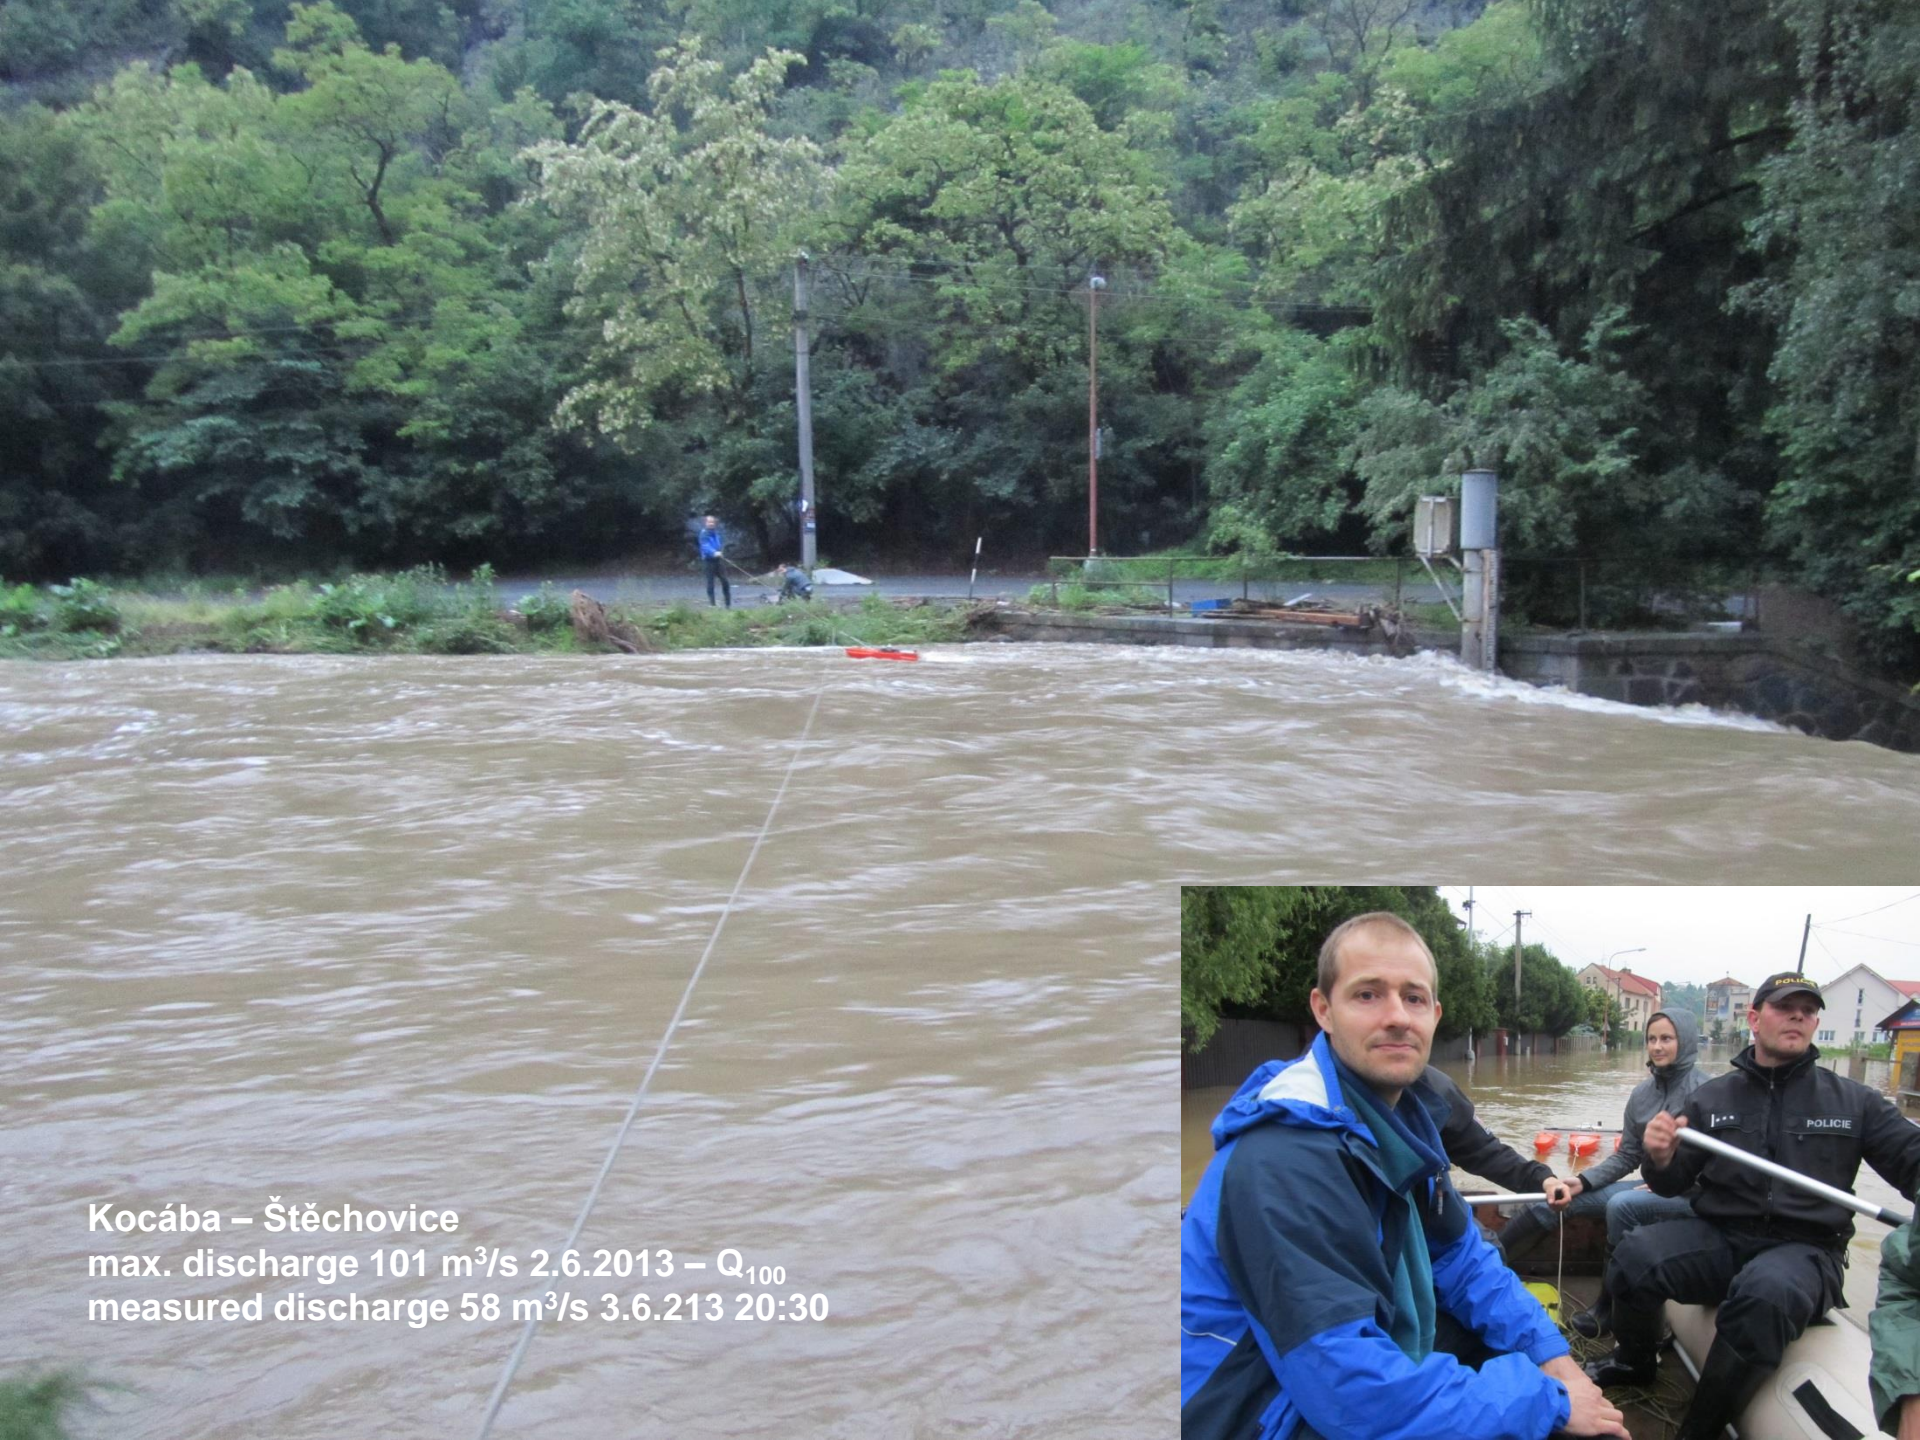
Kocába – Štěchovice  
max. discharge 101 m<sup>3</sup>/s 2.6.2013 – Q<sub>100</sub>  
measured discharge 58 m<sup>3</sup>/s 3.6.213 20:30

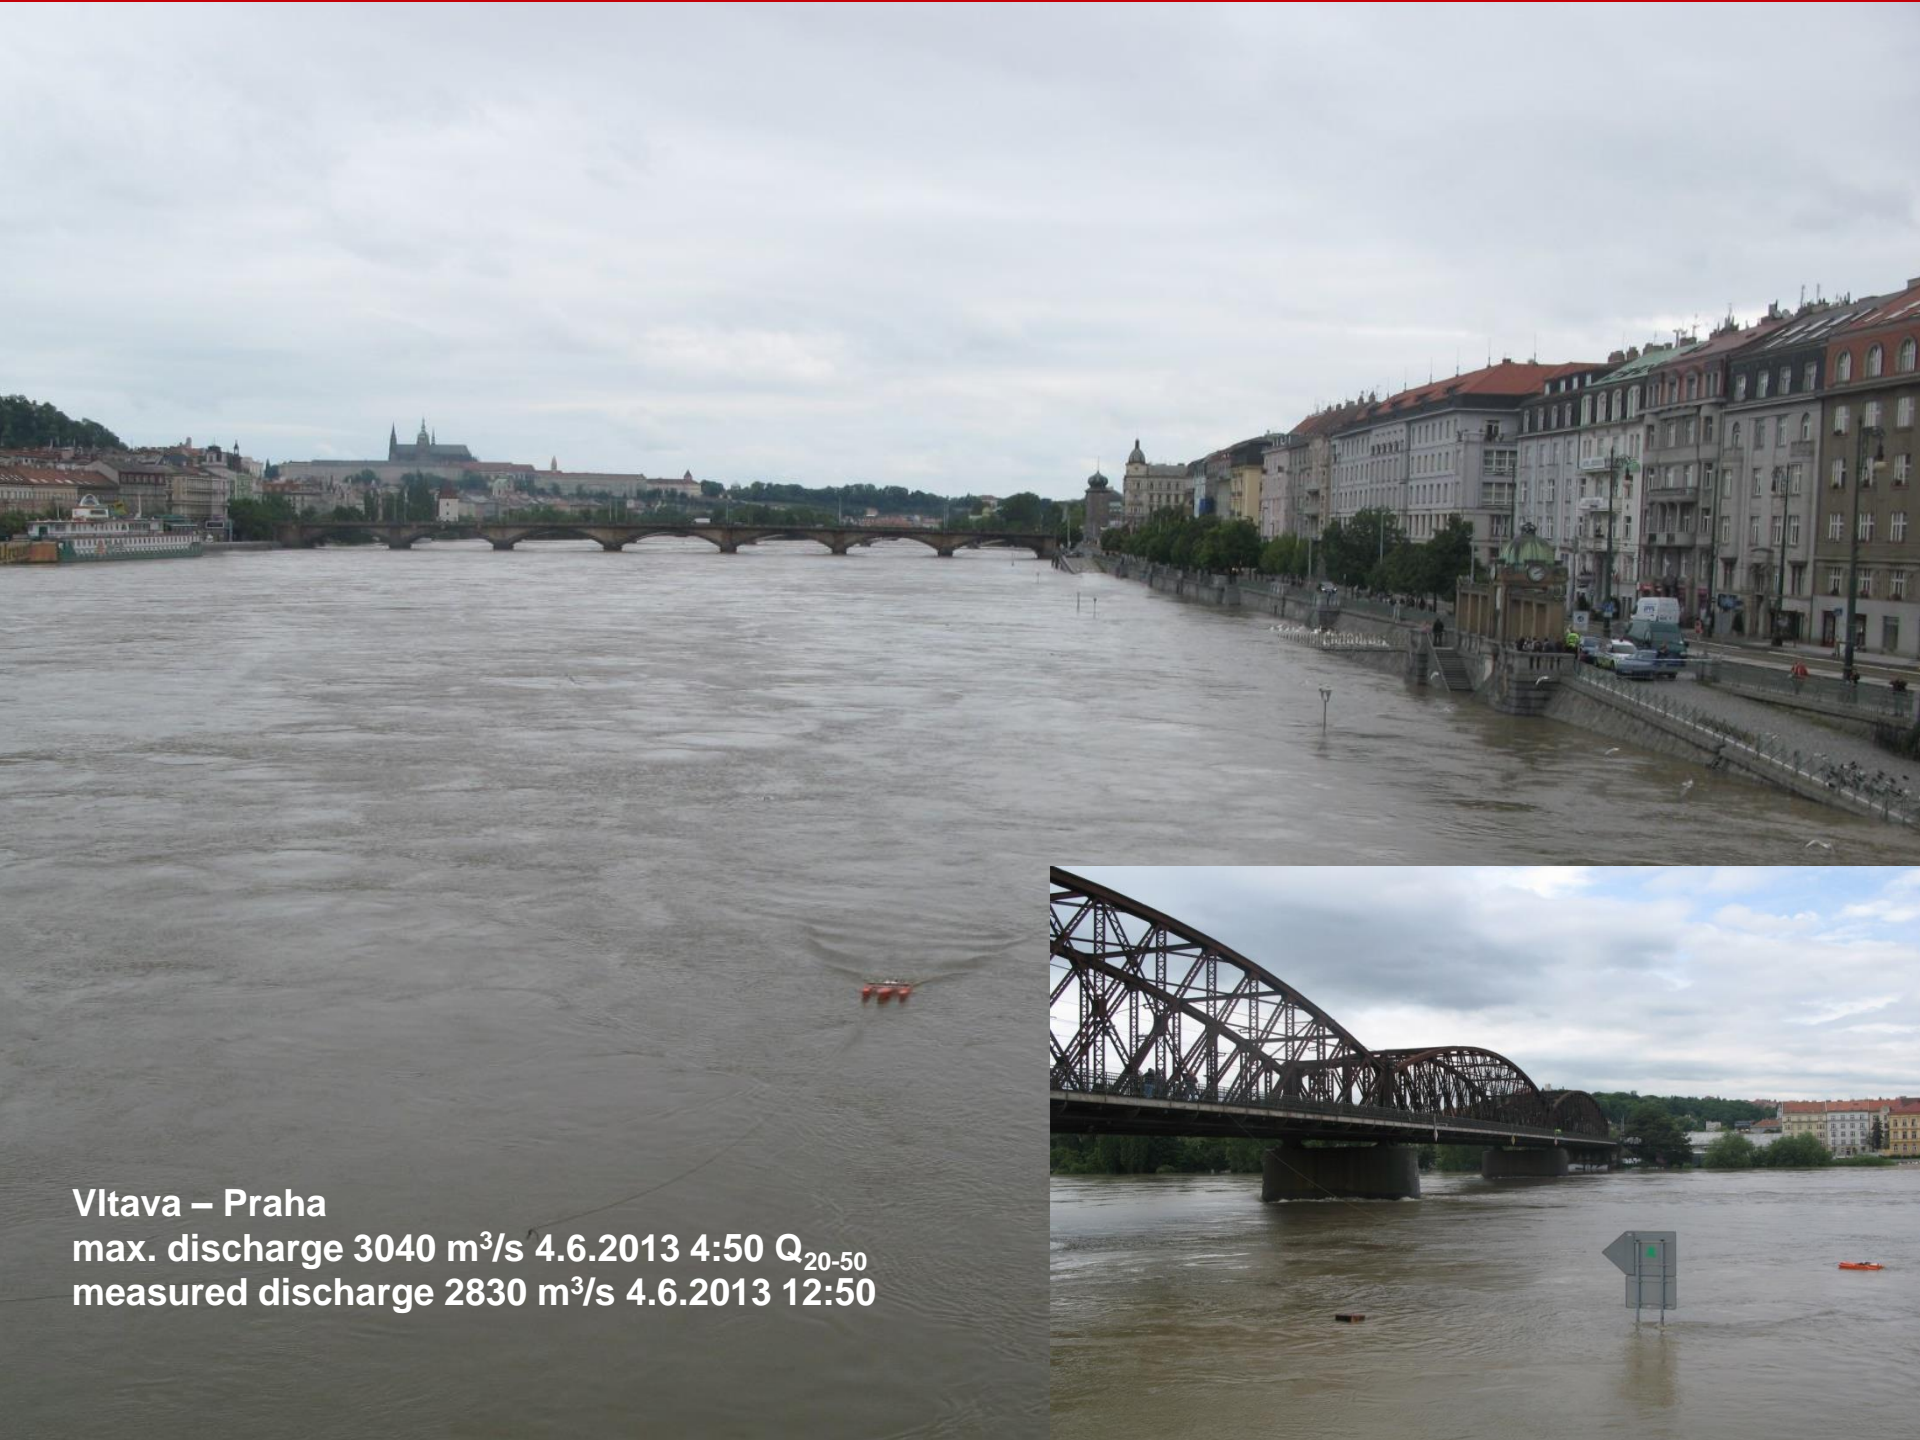
Vltava – Praha

max. discharge 3040 m<sup>3</sup>/s 4.6.2013 4:50  $Q_{20-50}$

measured discharge 2830 m<sup>3</sup>/s 4.6.2013 12:50

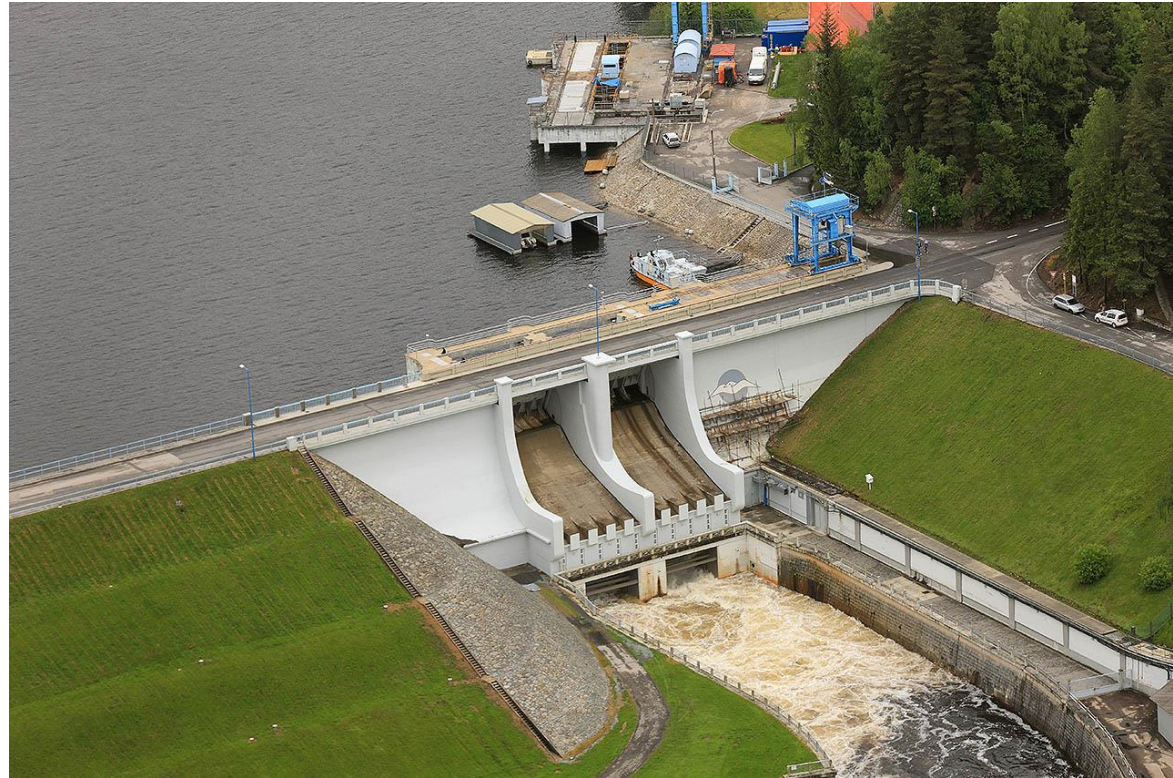
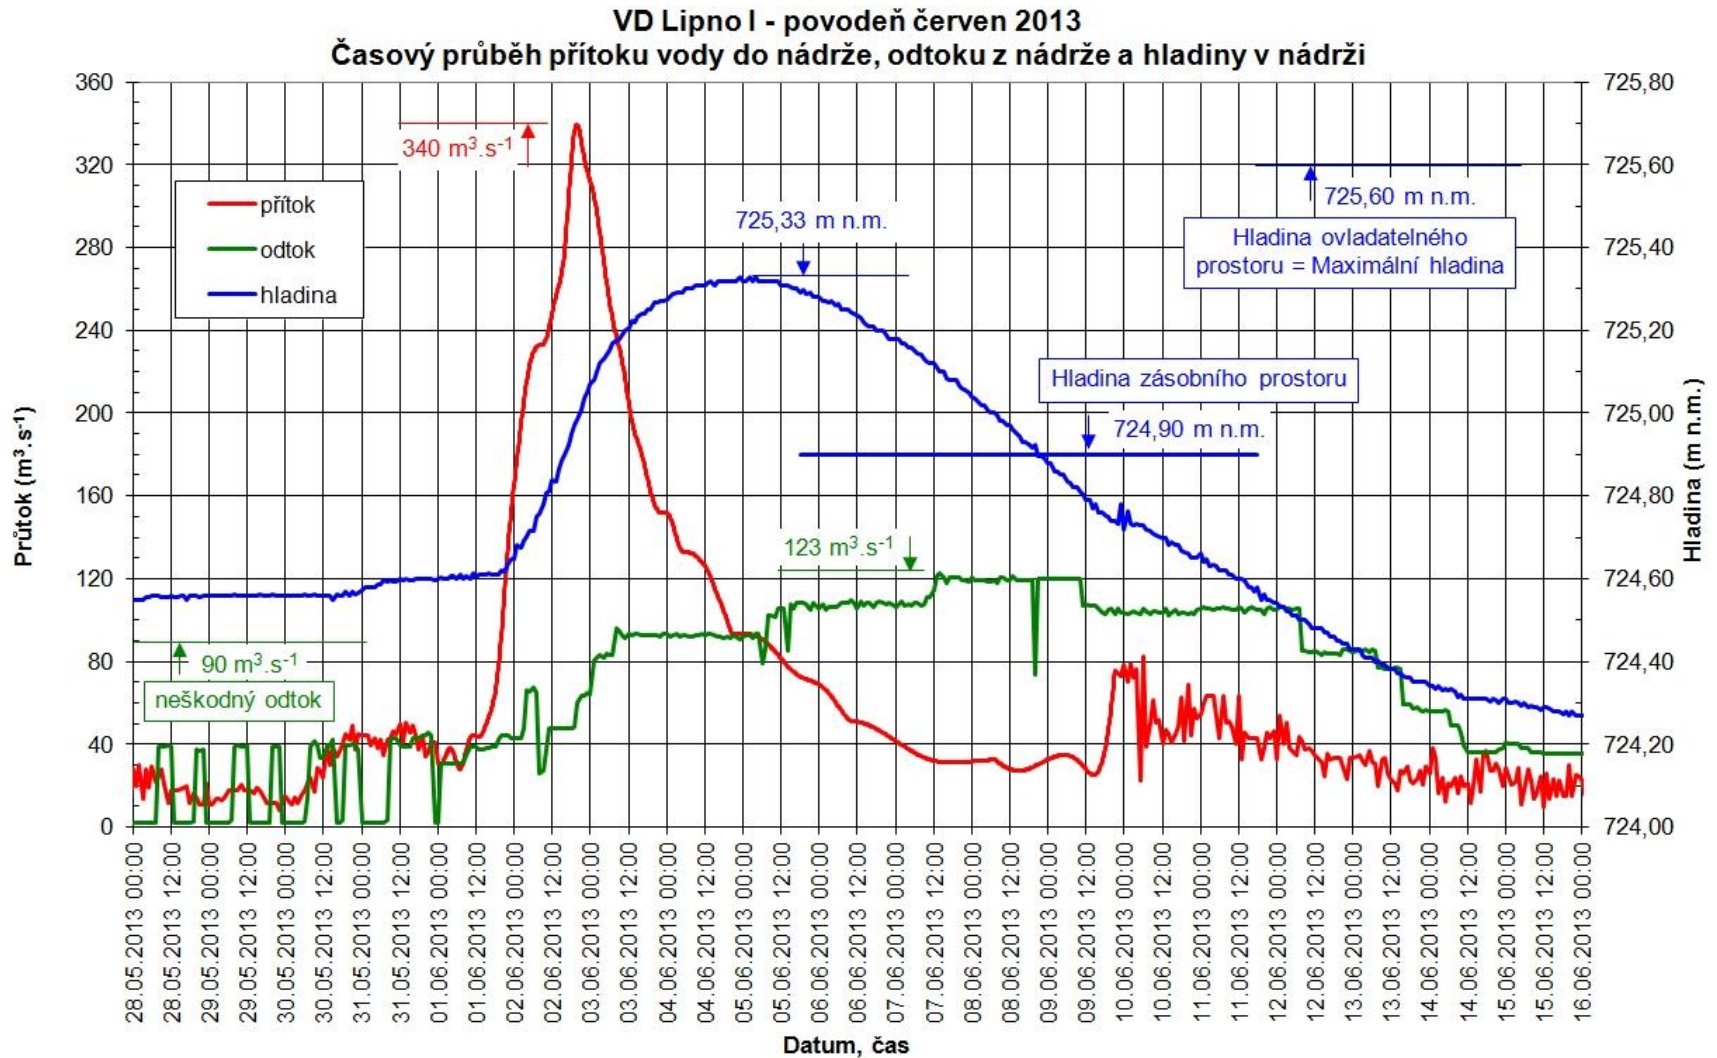
# Flood course at the Lipno I reservoir

**Inflow:**  
simple flood wave  
top discharge 340 m<sup>3</sup>/s  
Q50 – Q100

**Situation before flood**  
retention space empty  
+ 35 cm of storage room free

**Function:**  
max. outflow 123 m<sup>3</sup>/s  
culmination decreasing by 64%  
culmination postponing 5 days  
harmless outflow 90 m<sup>3</sup>/s was exceeded  
outflow in time of flood culmination was 60 m<sup>3</sup>/s only

Extraordinary manipulation 2.6.2013 evening ordered by Regional Flood Authority  
increasing of outflow above harmless outflow  
but considering situation in Český Krumlov (Vltava culmination at noon 225 m<sup>3</sup>/s)  
increasing of outflow was compensated by decreasing of flow from basin under reservoir

Inflow is calculated by water balance in reservoir (in 1 hour time step)

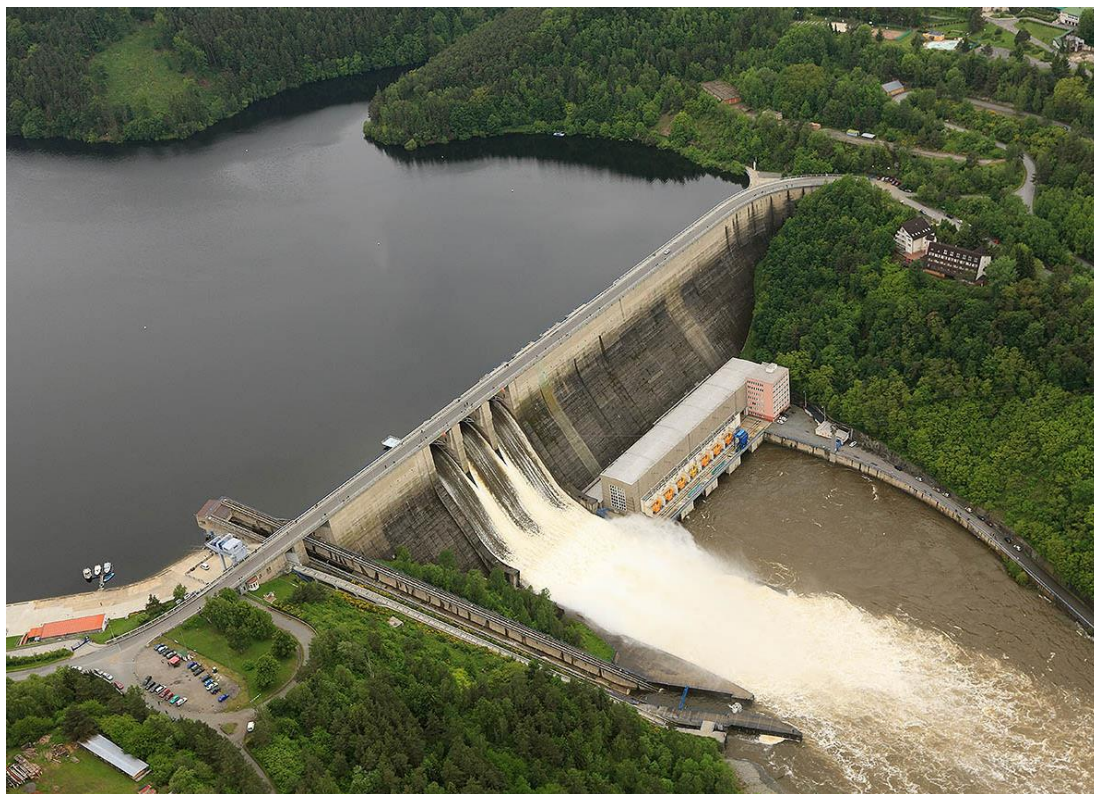
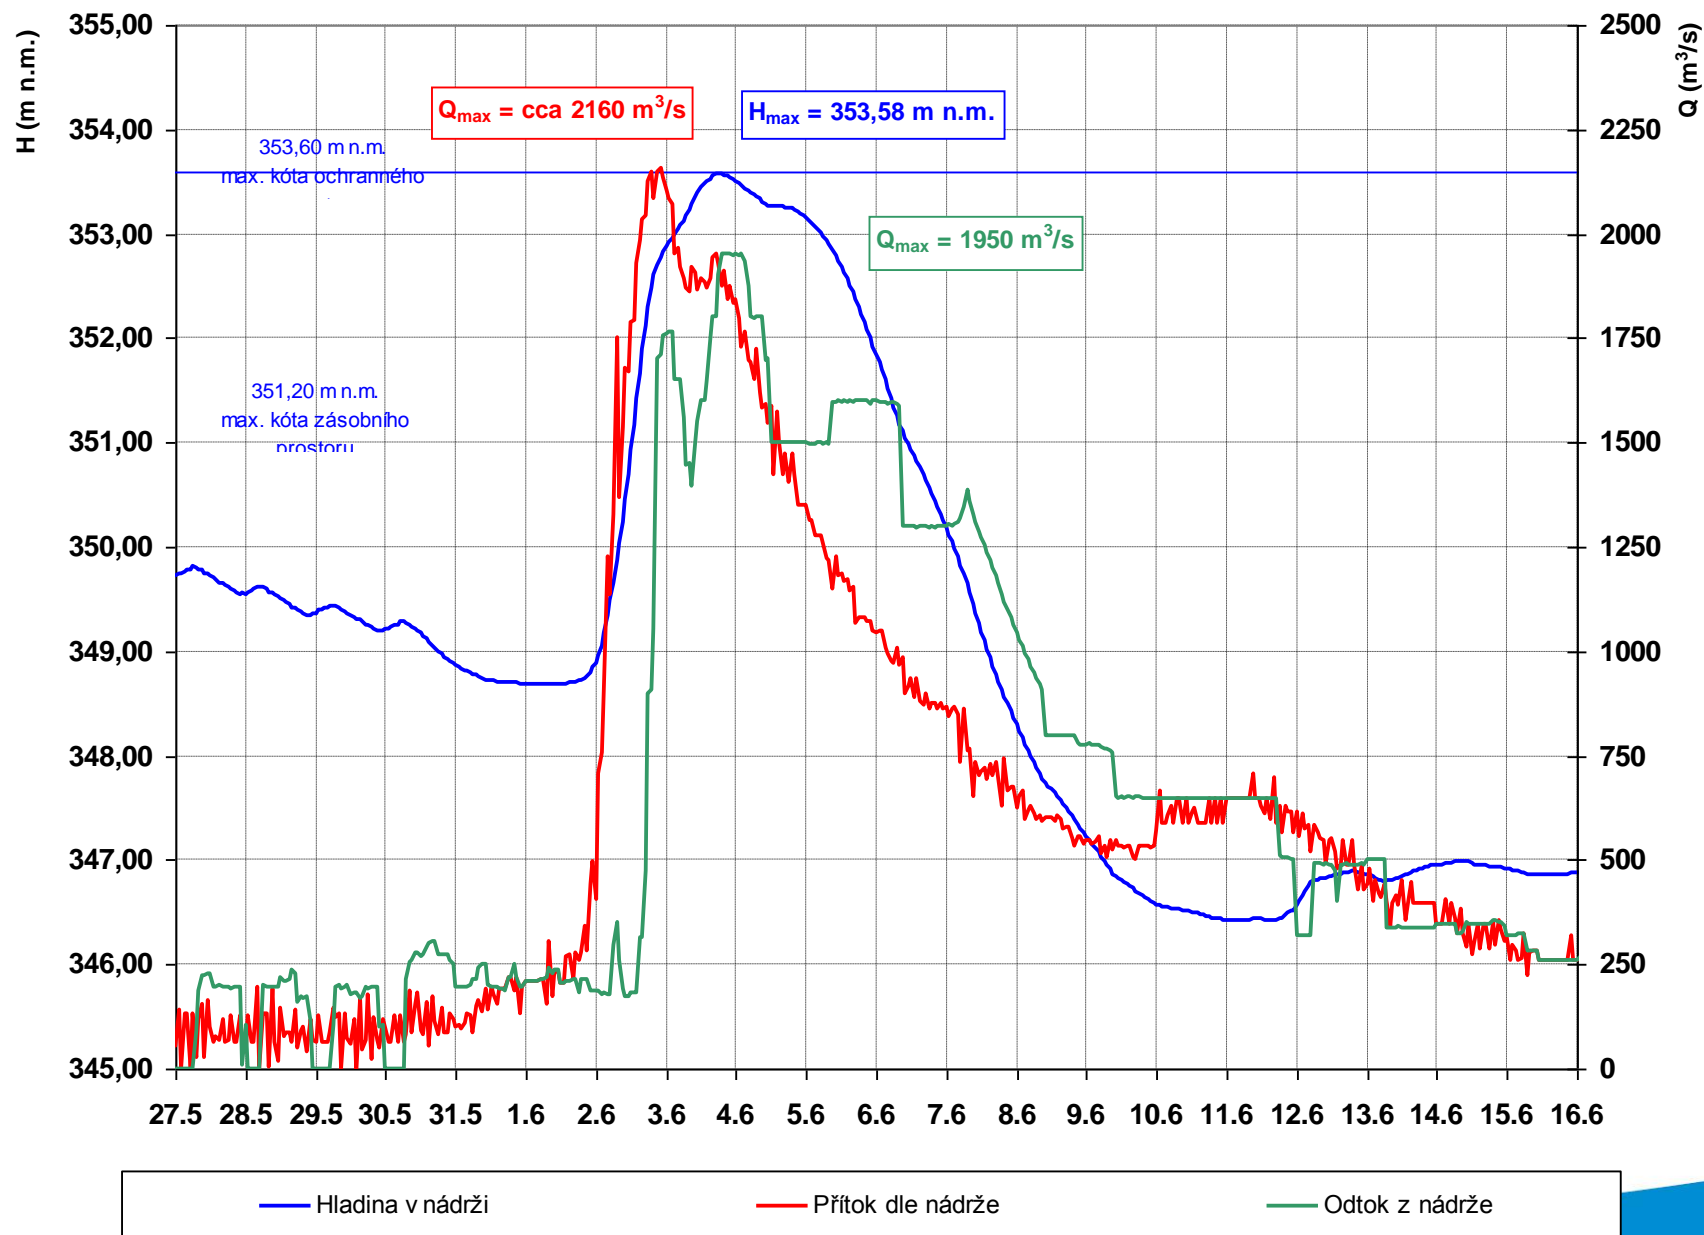
# Flood course at the Orlík reservoir

**Inflow:**  
flood wave with secondary hill  
top discharge  $2160 \text{ m}^3/\text{s} - Q_{100}$

**Situation before flood:**  
retention space empty  
part of storage room free  
2 times more free space than  
given by operational rules

**Function:**  
max. outflow  $1950 \text{ m}^3/\text{s}$   
culmination decreasing by  $210 \text{ m}^3/\text{s}$   
culmination postponing by 18 hours  
max. water level 253,58 m n.m.  
2 cm below permitted level  
entire using of retention capacity

**All manipulations according to Operational rules**

- outflow from the cascade was delayed  
to have time enough for safety works  
and building of mobile barriers in Prague
- extraordinary manipulation according to resolution  
of Supreme Flood Authority from 7.6.2013  
emptying of storage room for possible next flood wave

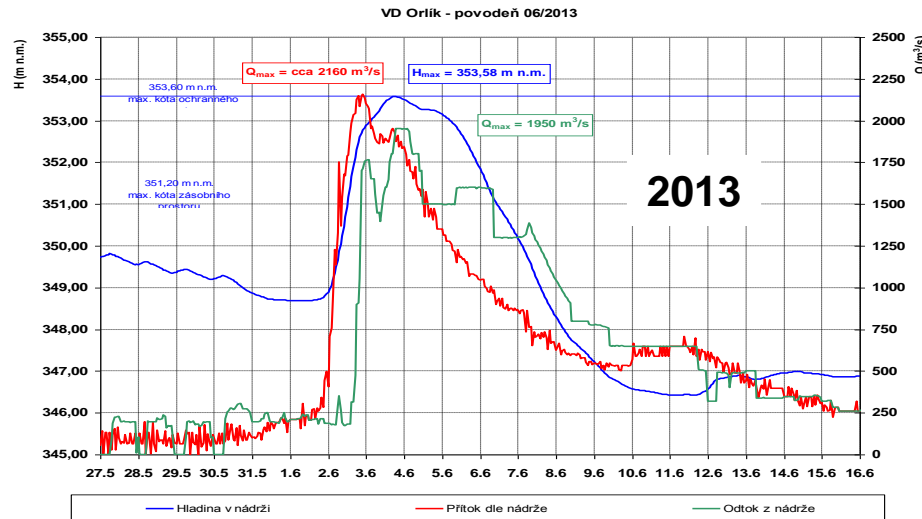
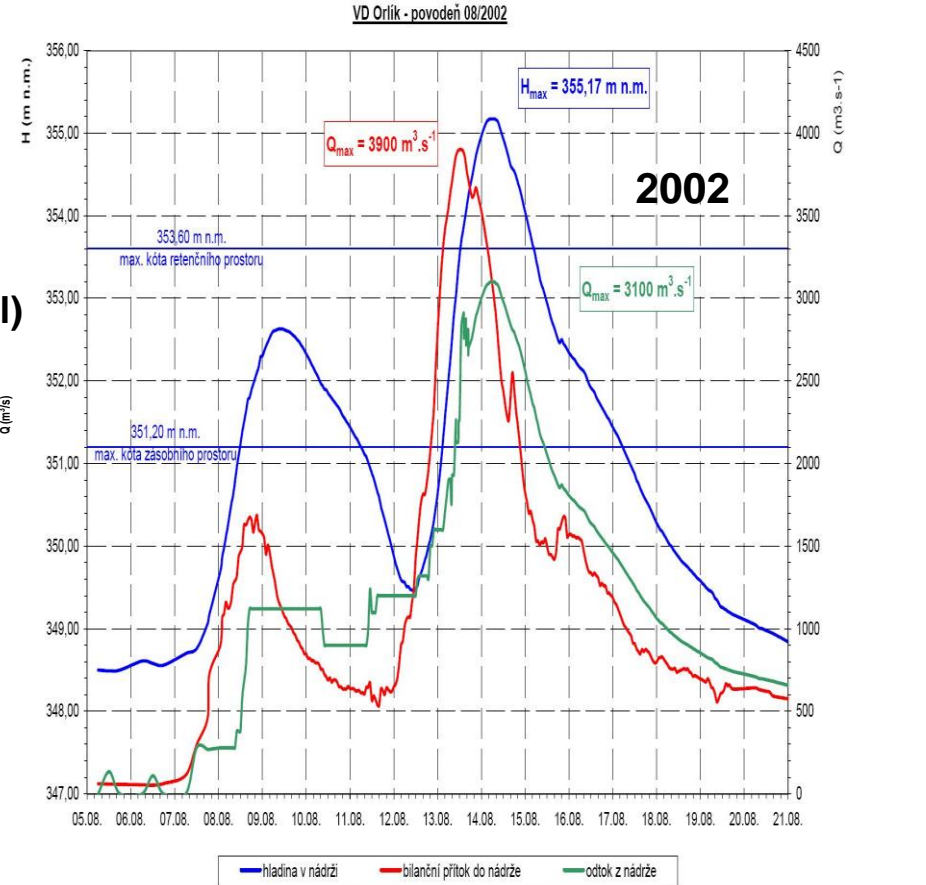
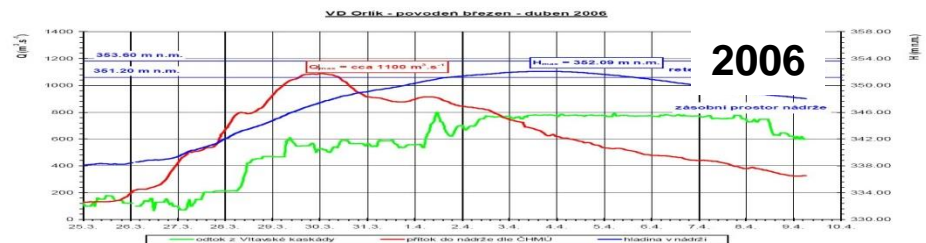
# Comparison of the Orlik effect in different flood situations

June 2013- quick start of flood wave

$$dQ = 210 \text{ m}^3/\text{s}$$

$$\max H = 353,58 \text{ (2 cm below max level)}$$

August 2002 – two flood waves in short time

$$dQ = 800 \text{ m}^3/\text{s} \text{ ( - 600 m}^3/\text{s power plant)}$$

March/April 2006 – spring flood, great volume

$$dQ = 400 \text{ m}^3/\text{s}$$

$$600 \text{ m}^3/\text{s} \text{ in time of culmination}$$

$$\max H = 352,09 \text{ (51 cm below max level)}$$
