# FLOODS IN JUNE 2013

Jan Kubát

Czech Hydrometeorological Institute

# Project on Assessment of June 2013 Flood

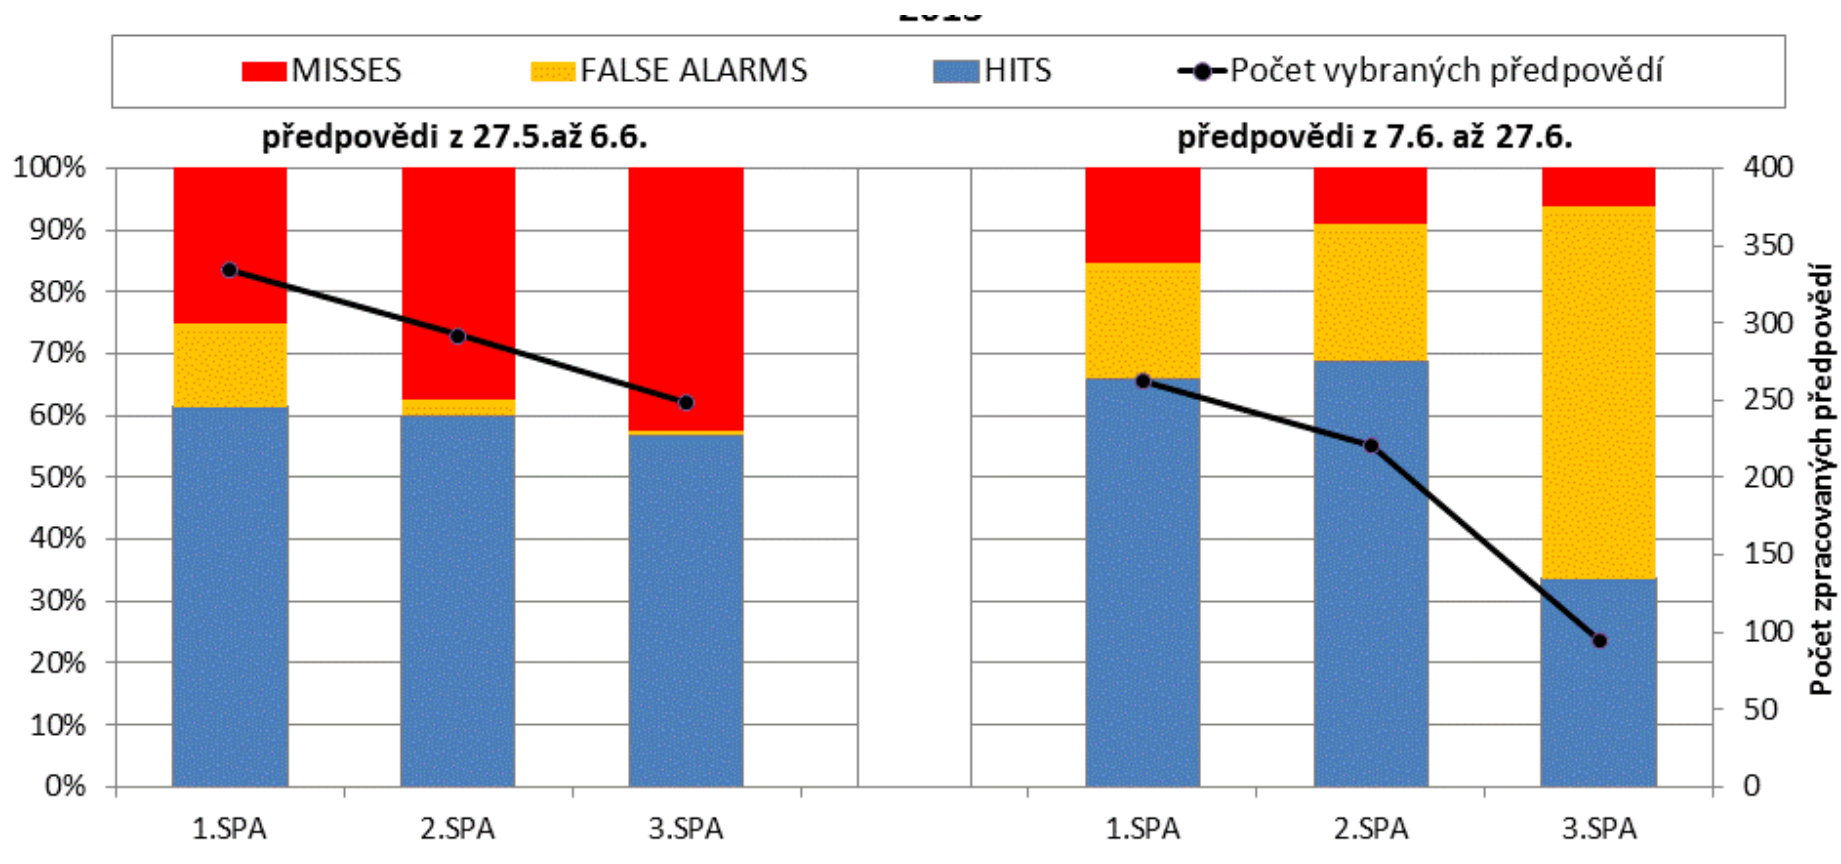
# Assessment of hydrological forecasts success

Achievement or over achievement of flood danger levels (1.SPA, 2.SPA, 3.SPA)

Category – successful forecast – phenomenon was forecasted and occurred – HIT  
 unsuccessful forecast - phenomenon wasn't forecasted but occurred – MISS  
 unsuccessful forecast - phenomenon was forecasted but didn't occur – FALSE ALARM

Difference in forecasts success between the first and the second flood wave

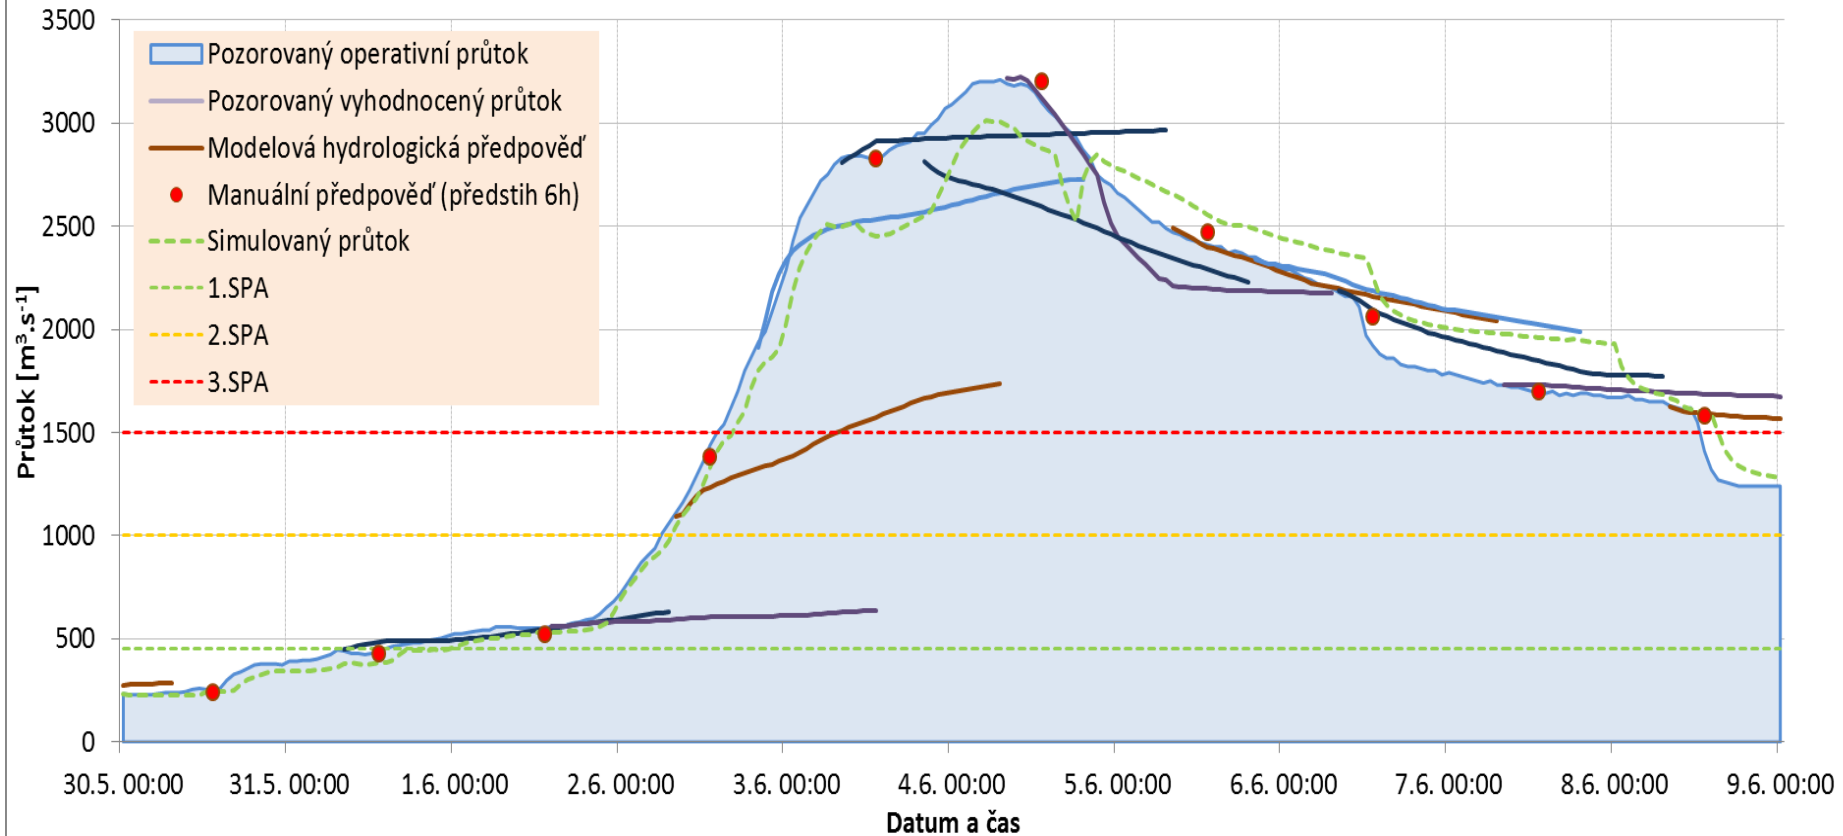
# Hydrological forecast for Vltava river in Prague

**Forecast for 48 hours didn't suit to the origin of flood wave**

**main reasons – weak precipitation forecast**

- weak hydrological forecast for Berounka and Sazava rivers
- reports on outflow from the Vltava cascade (2/3 of flow in Prague)

**green line – resimulation of hydrograph according to real outflow from the Vltava cascade**

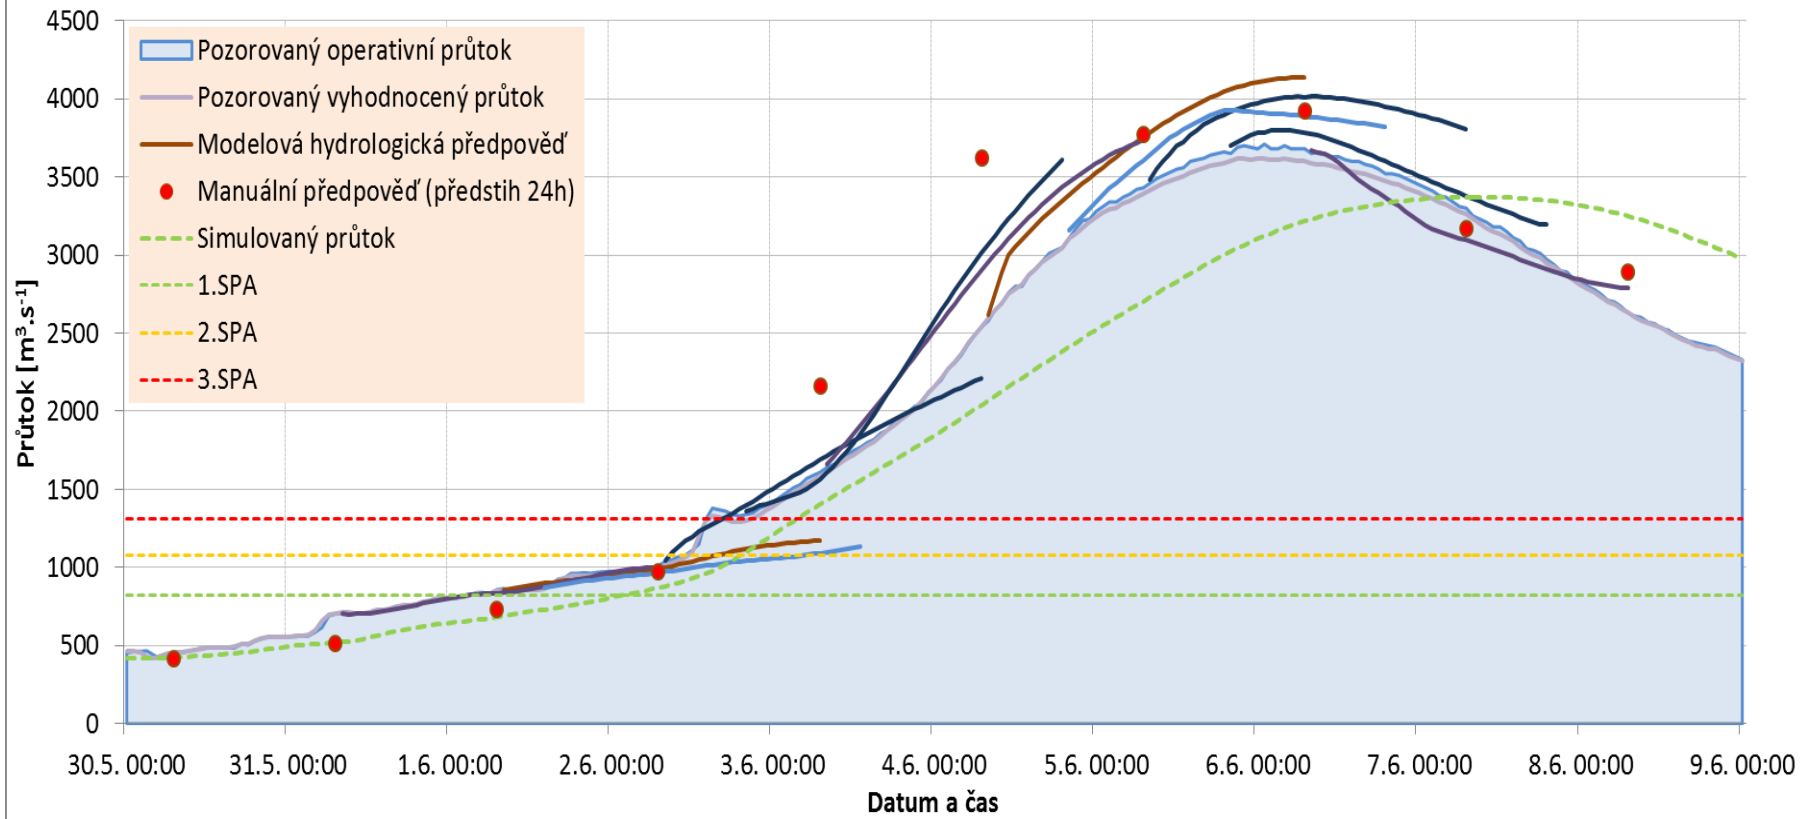
# Hydrological forecast for Labe river in Ústí n.L.

**color lines – 48 hours forecasts by hydrological model**

**red circles – 24 hours manual according to flood course in upper sites**

**didn't suit during the main part of flood wave**

**main reasons – doesn't depend on precipitation forecast**

- underestimated influence of large inundations (Mělník and Litoměřice areas)
- wrong information from upper gauging station (mainly from Prague) because of rating curve currently use during flood (difference about  $250 \text{ m}^3/\text{s}$ )

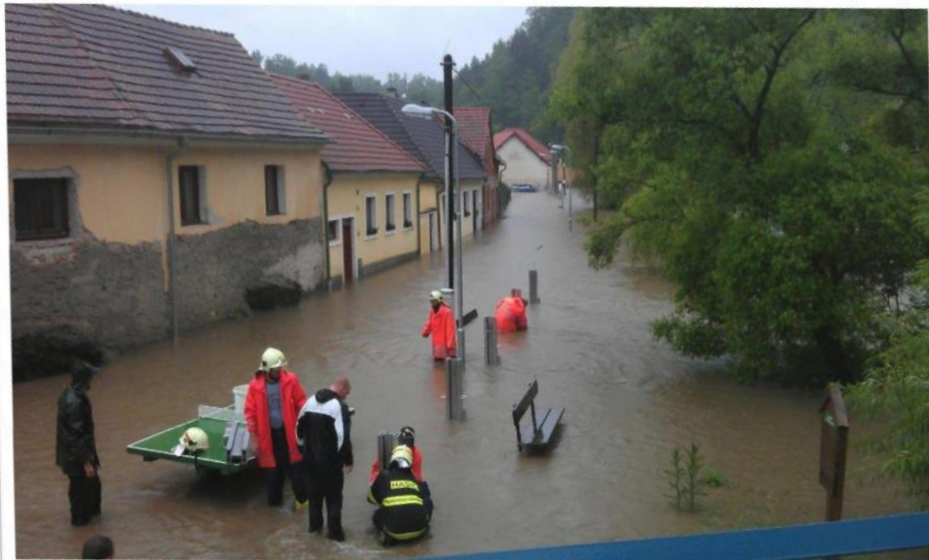
Bechyně – situation in June 2013

Problem is building of system on time in case of quick coming of the flood (Bechyně, Praha)

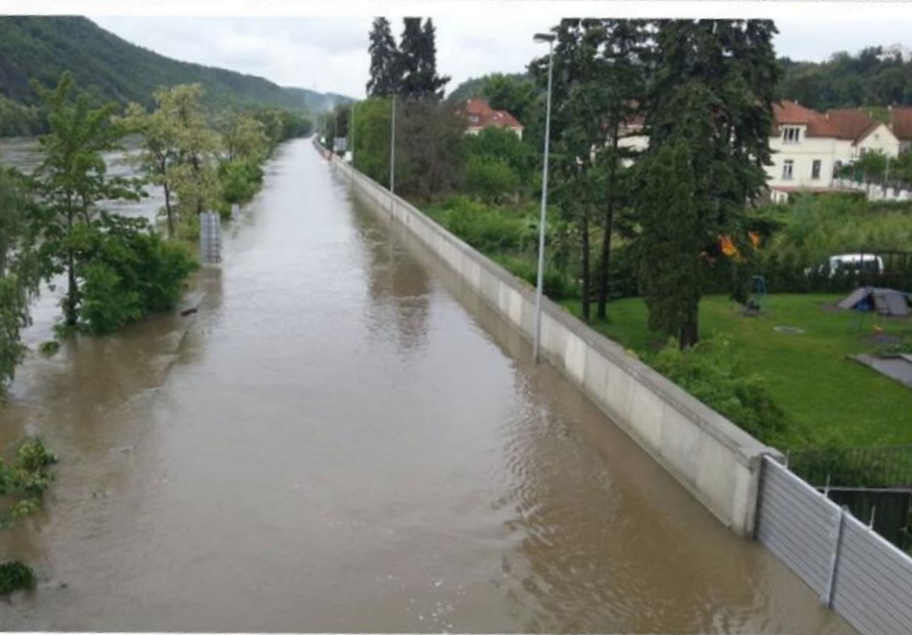
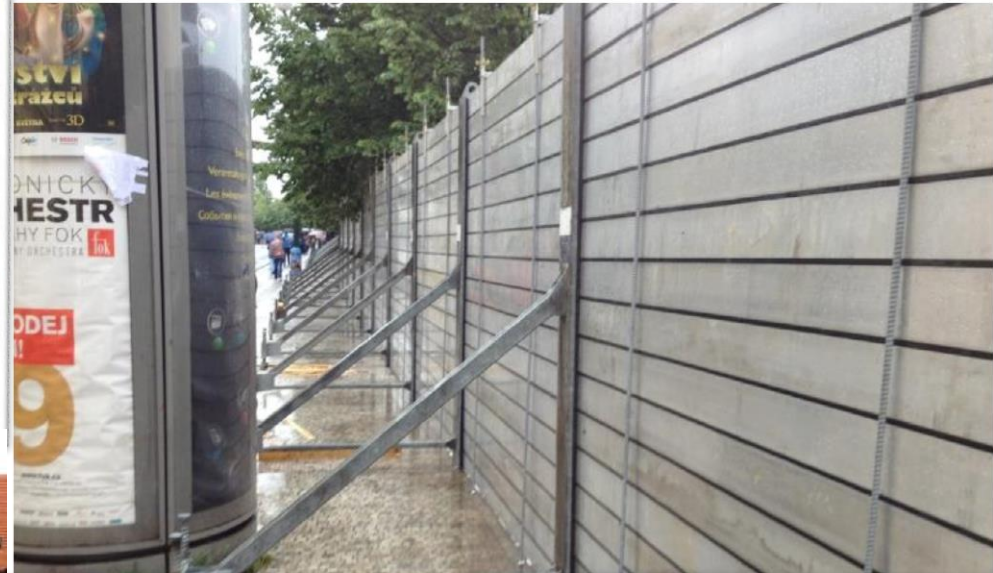
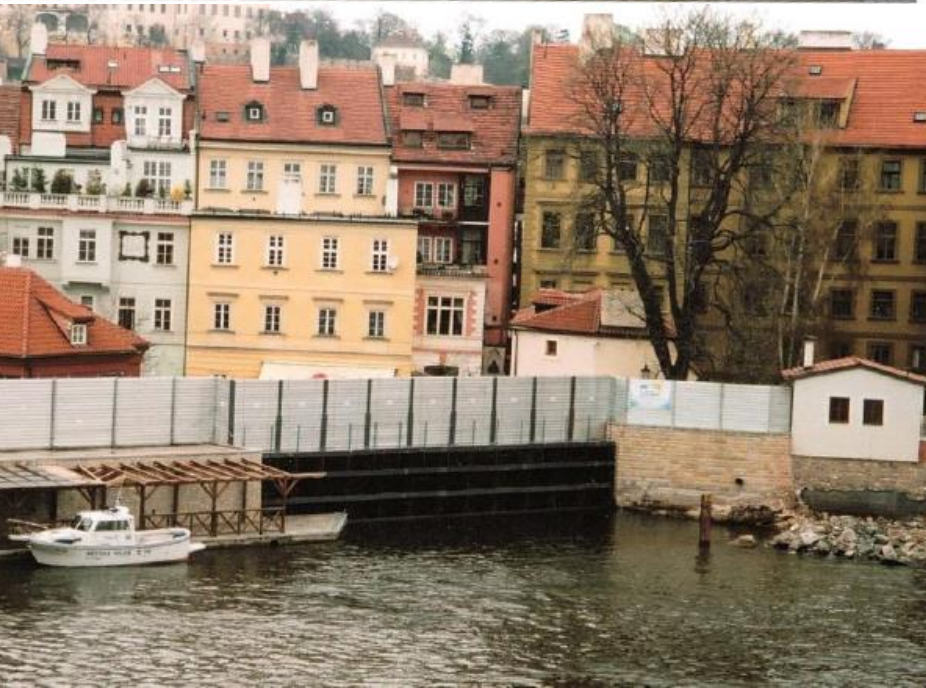
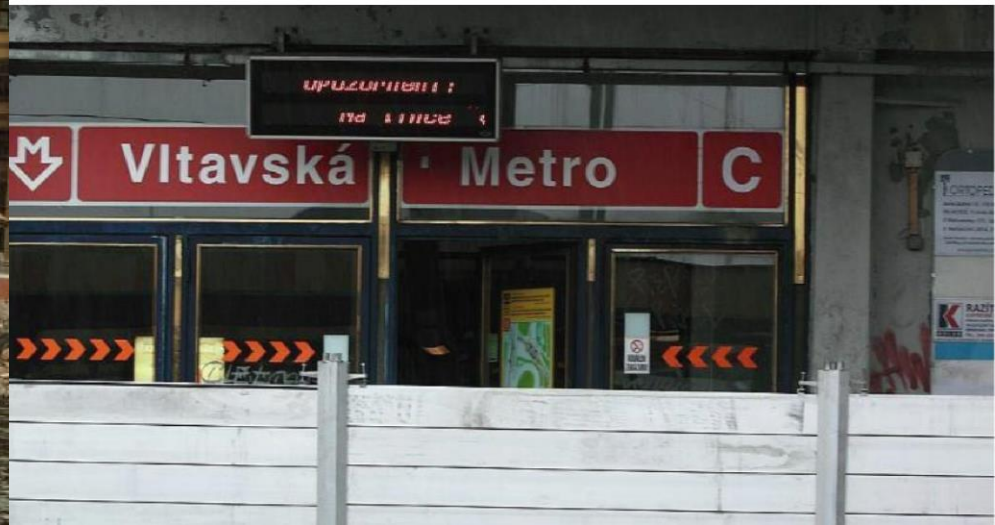
6,4 km mobile barriers

design level - flood 2002 + 30 cm

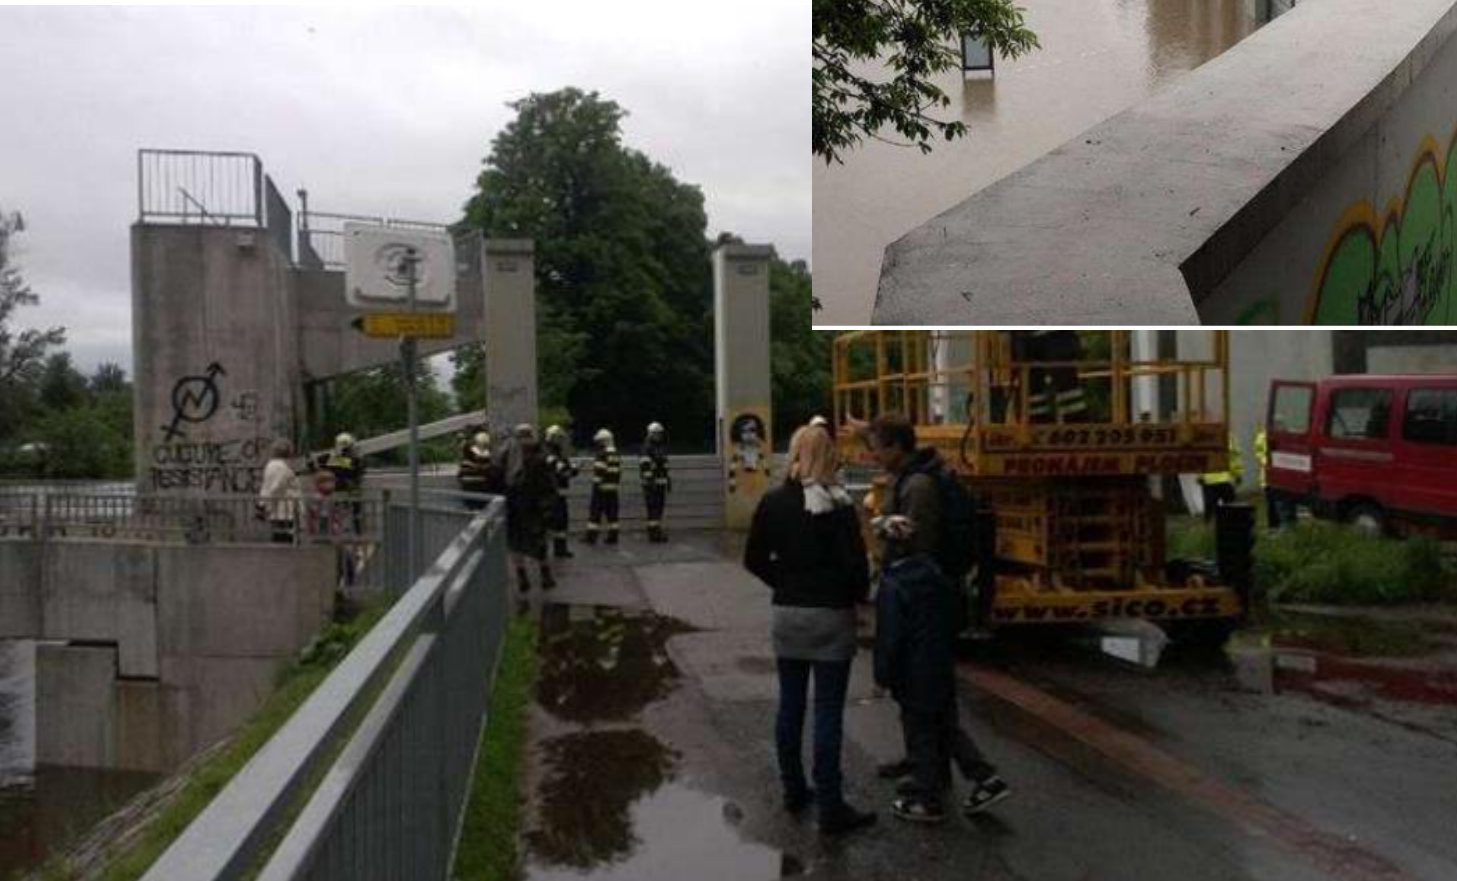
# Flood protection measures in Prague - Libeň

**Problem of flood occurrence  
in Vltava river and Rokytká river  
in the same time**

**top discharge in Rokytká 45 m<sup>3</sup>/s  
capacity of pumping station 20 m<sup>3</sup>/s**

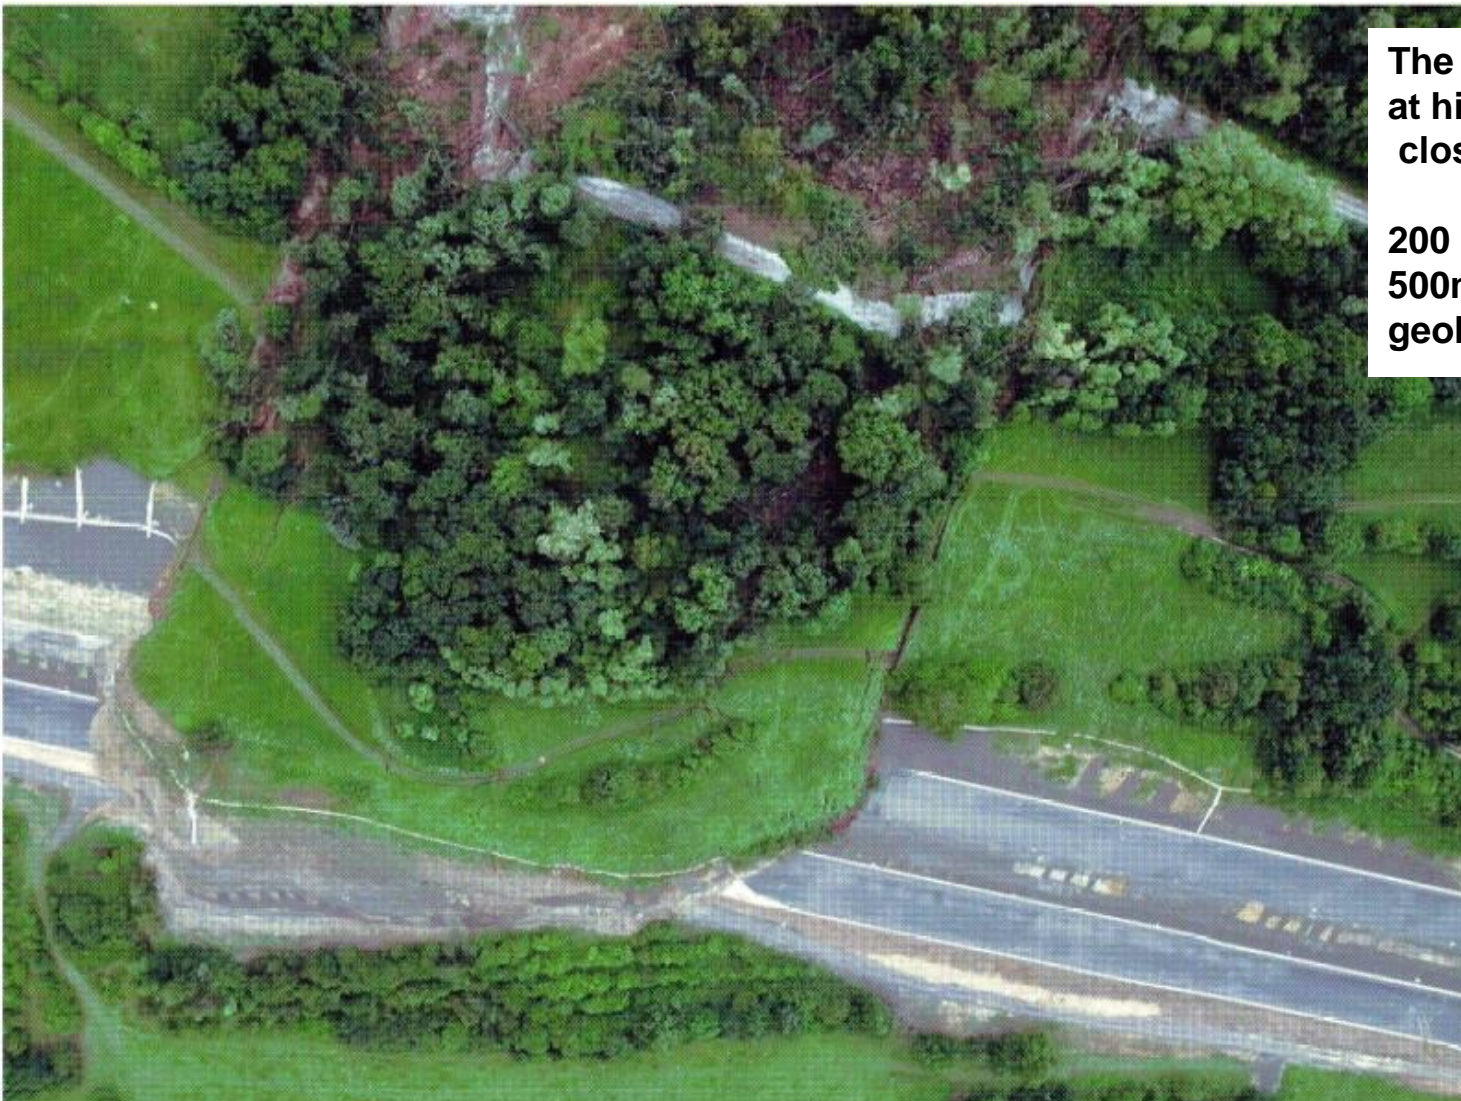
Together 124 landslides were detected, from that 19 slides with high risk of continuation (III. category) most of slides were detected in Middle Czech region and Ústí region

The greatest landslide  
at highway D8 building site  
close to Dobkovičky village

200 m width  
500m long on slope  
geological survey is done
